# DRAFT ENGINEER'S REPORT

November 10, 2022

**KILLEARN ROAD STUDY**

**TOWN OF WASHINGTON  
DUTCHESS COUNTY, NY**

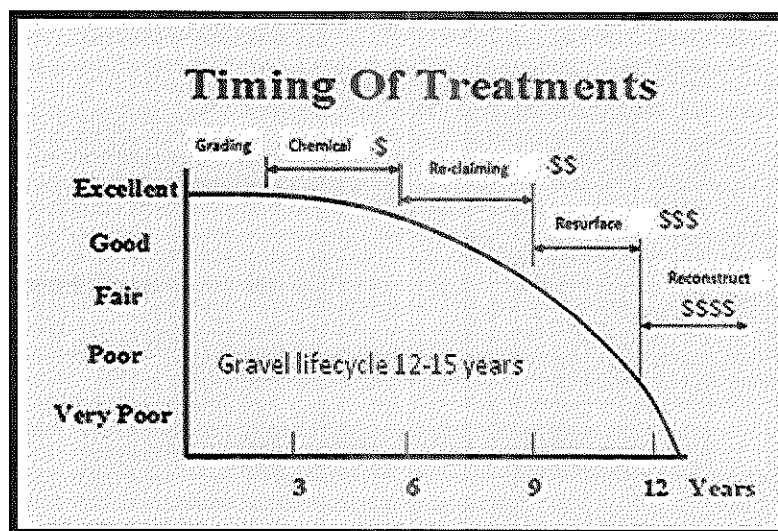
Figure 2 – Gravel Road Life Cycle and Costs<sup>2</sup>

What can be gained from examples like Adams County is their experience with planning road maintenance and repair programs. In their experience, a gravel road may have only a 15-year

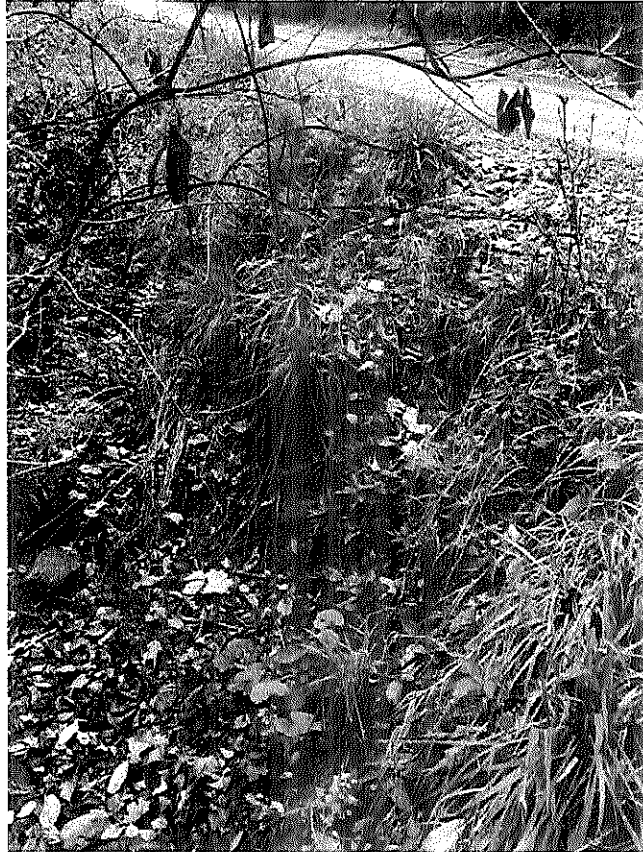
*Figure 7 - Embankment Erosion near 623 Killearn Road*

- At 623 Killearn Road (Sta. 7+00) and just north of 252 Killearn Road (Sta. 94+00) there are signs of runoff eroding a hole through the built-up embankment sides.

Runoff appears to run parallel for a distance along the road edge due to a lack of drainage ditch adjacent to the road. This has led to erosion on the road edges and created the natural built-up embankment at each side of the roadway. Eventually the surface runoff has broken through the built-up sides and has eroded the embankment slope down to an existing culvert outlet. Both locations this occurs are low points along the road, and the embankment erosion occurs on the downstream side.

This issue occurs in multiple locations due to poor drainage relief.

- Gravel surface rutting near 596, 452, 430, 68, & 48 Killearn Road
- Settlement at 252 Killearn Road existing culvert crossing
- Embankment erosion at 623 & 387 Killearn Road
- Culvert repair/replacement at 387 & 108 Killearn Road, and all others as deemed necessary
- All potholes, rills and erosion encountered on the road by spot-filled and compacted with a 10-ton roller.
- A layer or topping stone placed along the entire road and graded with crown.
- Post a weight limit on the road and establish a permitting process for larger vehicles.

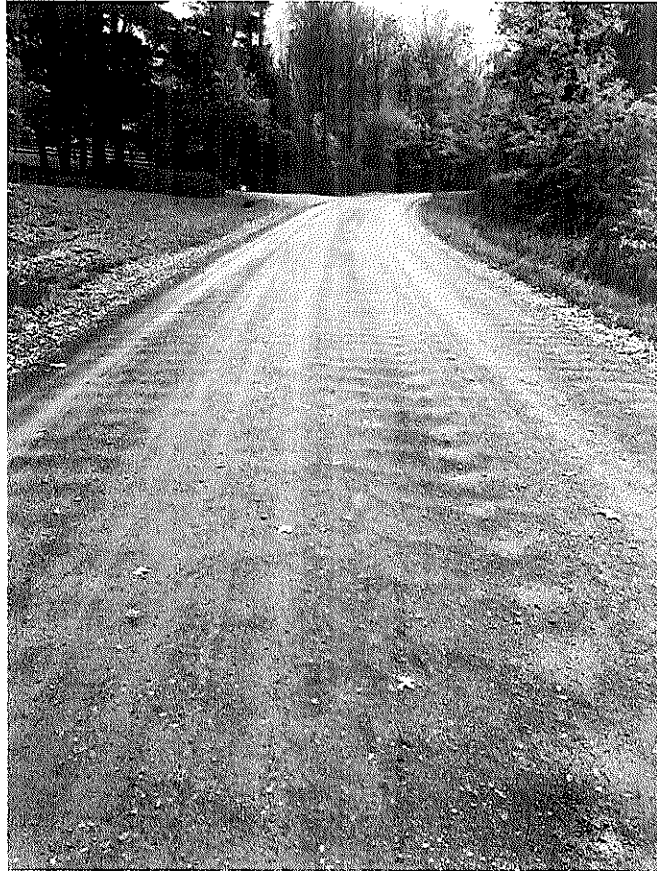
*Figure 8 – Typical Gravel Surface Rutting*

- At 452 - 460 Killearn Road (Sta. 50+00±), there is a large section experiencing severe rutting (sometimes called "Washboarding") as a result of heavy vehicle traffic on the road. The construction vehicles appear to make multiple trips in each direction during the day, wearing down the existing gravel surface, for approximately 200-ft.

The area shown in above Figure 8 was the worse area of rutting CED observed. However, smaller areas of rutting existing throughout the 3.29-mile corridor.

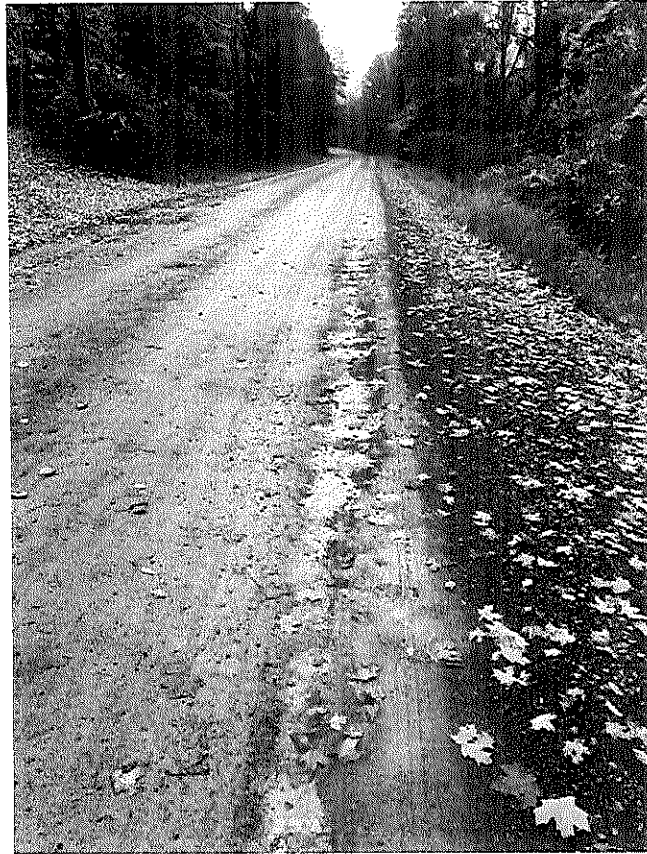
*Figure 9 - Rutting and Potholing near 430 Killearn Road*

- At multiple occurrences, there are large sections of potholing and ruts within the travel lanes. The areas pool with water and are further deteriorated during rainstorms.

Areas with the worst deterioration occur at 596 Killearn Road (Sta. 13+00), at the driveway entrance to 430 Killearn Road (Sta. 56+00) extending approximately 250ft South beyond the driveway, and at the driveway entrances to 68 & 48 Killearn Road (Sta. 155+00).

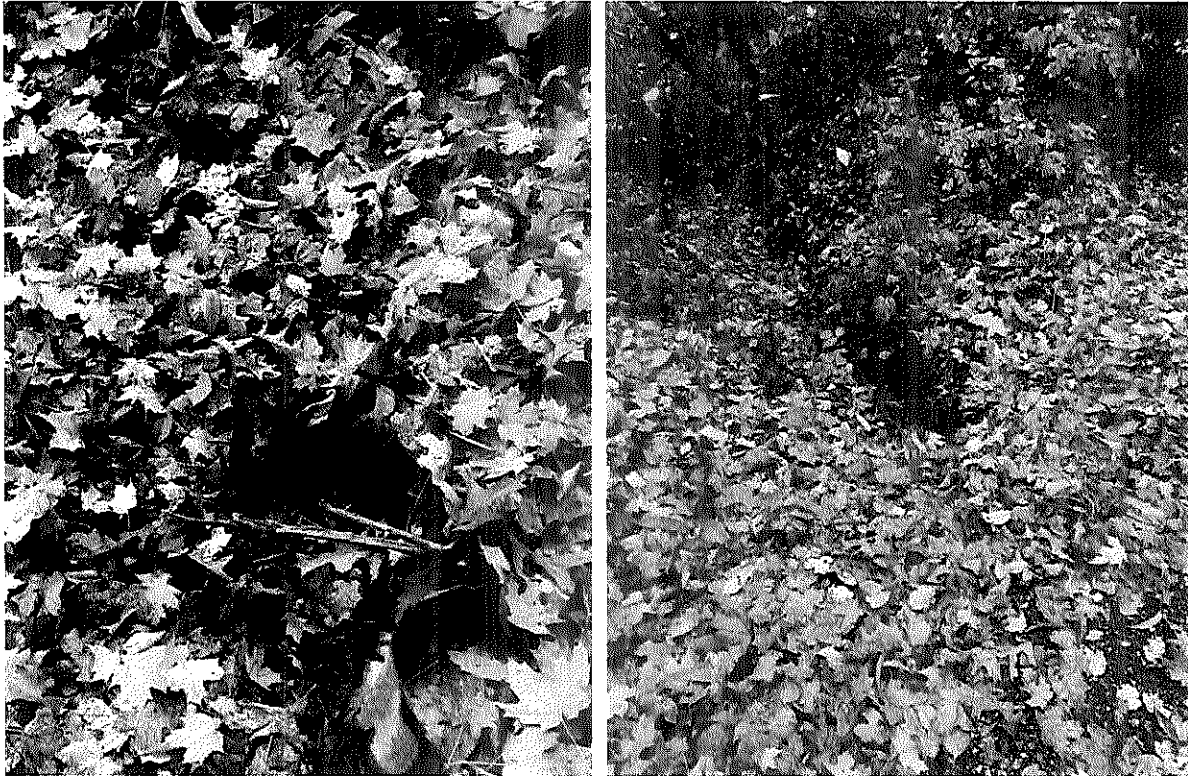
*Figure 10 – Collapsed Culvert and Embankment Erosion 387 Killearn Road*

- Approximately 200ft south of the driveway entrance to 387 Killearn Road (Sta. 69+50), the existing 12" CMP culvert crossing beneath Killearn Road is crushed and the inlet is heavily silted and blocked with debris and vegetation. There are signs of runoff overtopping the roadway, due to the blocked pipe inlet, before running off the downstream side embankment. The downstream embankment slope is eroded, and the top of pipe is exposed up to the edge of the travel lane.

A number of culverts on the road are in similar condition. In fact, CED had to visit the site multiple times to find some culverts that were buried or missed in earlier site visits.

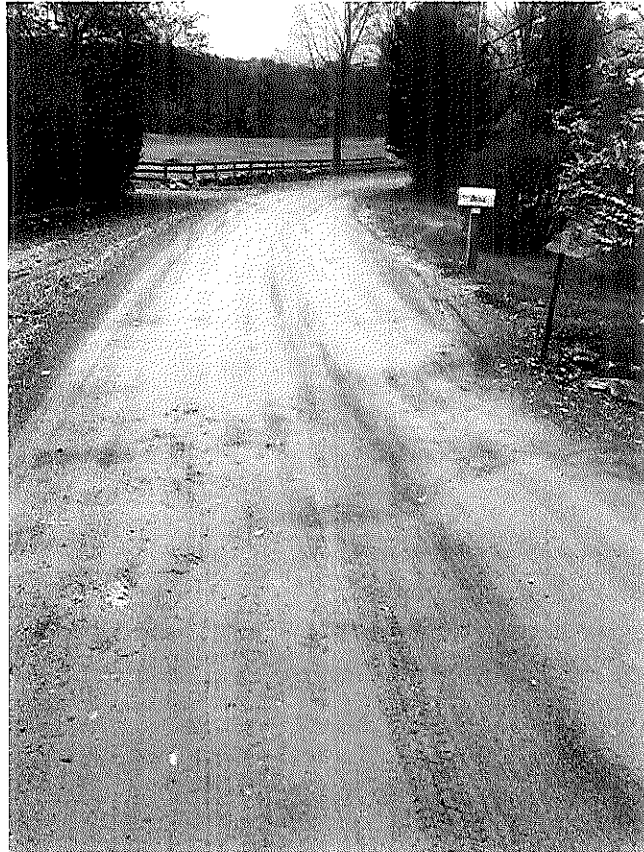
*Figure 11 – Roadway Settlement, 252 Killearn Road*

- At 252 -254 Killearn Road (Sta. 103+25), north of the driveway entrance, there is an existing culvert crossing beneath the roadway that is showing signs of settlement. The road edge is lined with stone headwalls on each side, at the inlet and outlet of the pipe. The road area directly above the culvert is visibly depressed below grade. The pipe does not exhibit any signs of failure or crushing, however the embankment slopes and shoulder show signs of erosion at the stone headwalls.

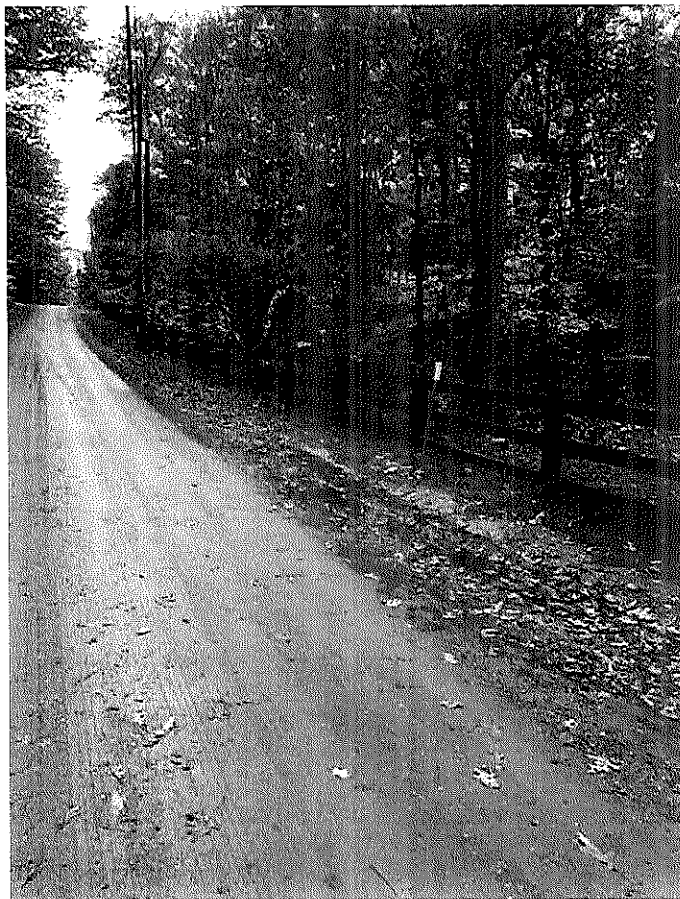
*Figure 12 – Roadway Ponding, 108 Killearn Road*

- At 108 Killearn Road (Sta. 143+00), the existing culvert is silted and blocked, leading to ponding along the roadway edge. The edge of the travel lane is mudded, and ponding has backed up into the property's front lawn. There are signs of ponding encroaching into the travel lane.

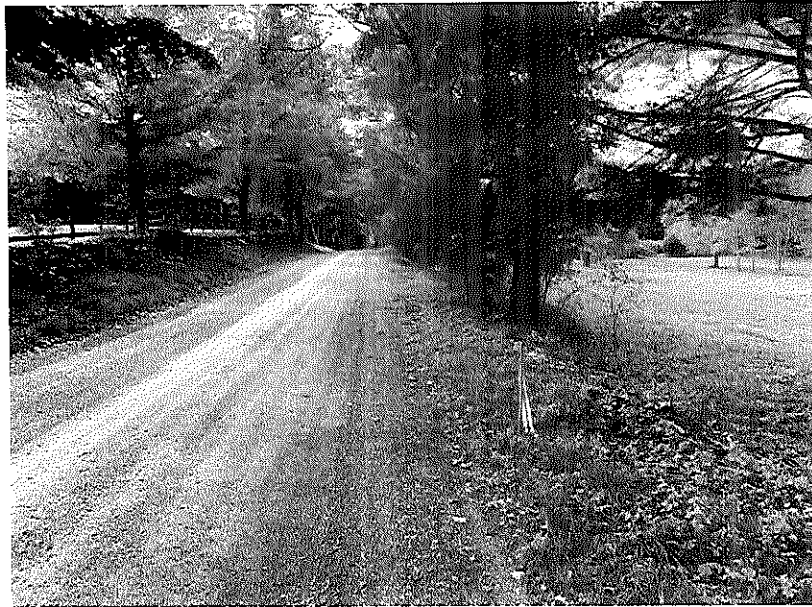
*Figure 14 – Built-up or Higher Embankment*

In addition, Killearn Road lacks an appropriate crown for much, but not all of the 3.29-mile alignment. A road crown helps to convey water off the travel way quickly. Without a crown ponding and potholing within the travel lanes at numerous locations has occurred along Killearn Road. Further, lack of a road crown also results in surface runoff leaving the roadway to concentrate and erosion through built-up embankment sides.

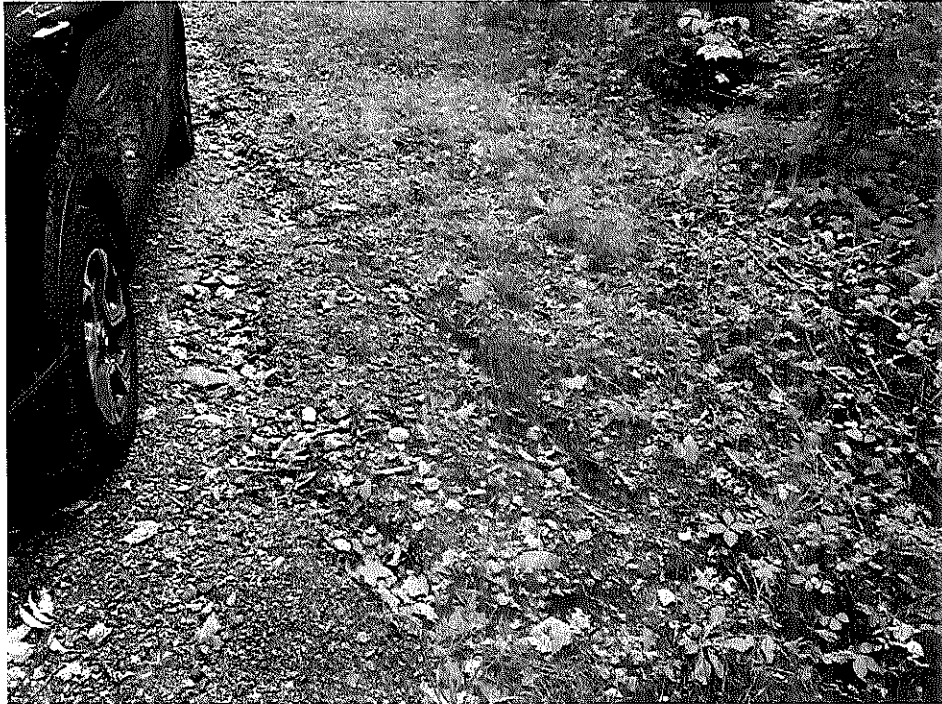
Rilling (a shallow channel no more than inches deep cut into soil by the erosive action of flowing water) in the side slopes has also occurred throughout the road length on each side of the roadway, most notably at the low points of the road, see **Figure 15** below. As erosion of the side slopes continues to expand, it is likely to undermine the roadway section and lead to road section failure. These conditions were observed during site visits conducted in summer and fall months on 2022. Through discussions with the Town, the deterioration and conditions are much worse during the winter and spring months, as a result of snow melt in addition to rainstorms.

*Figure 15 – Typical Rills and Soil Erosion at Low Points*

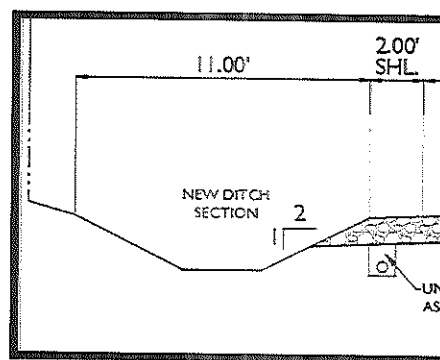
Figure 16 – Typical Ditch Section

New drainage ditches would be excavated and installed adjacent to the proposed roadway shoulders. Drainage ditches would consist of a 3ft wide grassed bottom, approximately 1.5ft deep. Beyond the ditch backslope, embankment will be graded to meet existing ground within the Right-of-Way. These ditches can intercept water from adjacent properties from entering and damaging the road and drain the road surface as well. This can lead to improved site and roadway conditions, while minimizing actual roadway repairs and preventing future deterioration of the existing gravel road.

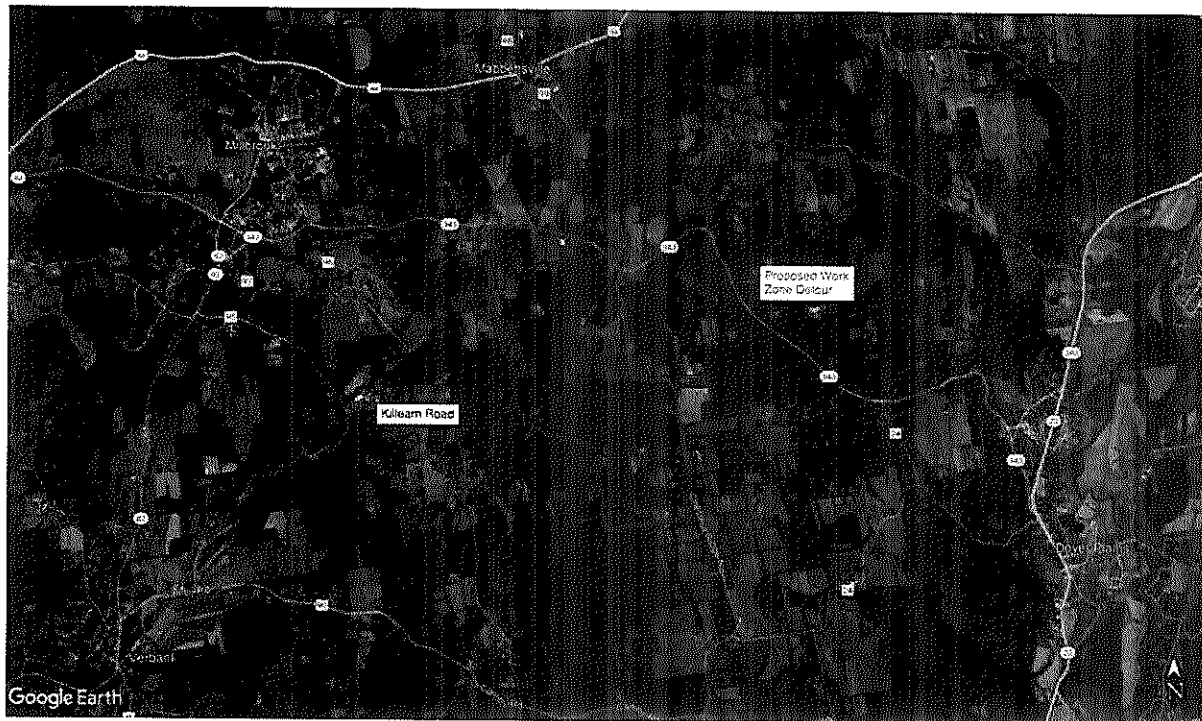
An offsite detour is the recommended method of traffic control for the project, utilizing State Route 343 and Chestnut Ridge Road. Traffic going eastbound on SR 343 may continue East to the intersection of Chestnut Ridge Road and turn South. Traffic going northbound on Chestnut Ridge Road may continue North before turning West onto SR 343. The road would remain open to local traffic and residents along Killearn Road.

*Figure 19 – Proposed Detour Plan*
