RE: Clear Subdivision
135889-6766-00-021055-0000
515 Woodstock Road
Town of Washington, NY

This letter is in response to the public comments regarding drainage concerns raised at the planning board's public hearing on October 1, 2024, relating to cluster vs. conventional subdivision. Specifically, comments asserted that flooding has been occurring along Stanford Road in the area of the Clear property, and that water from the west of Stanford Road was flowing across the road and impacting one or more properties on the east side of Stanford Road.

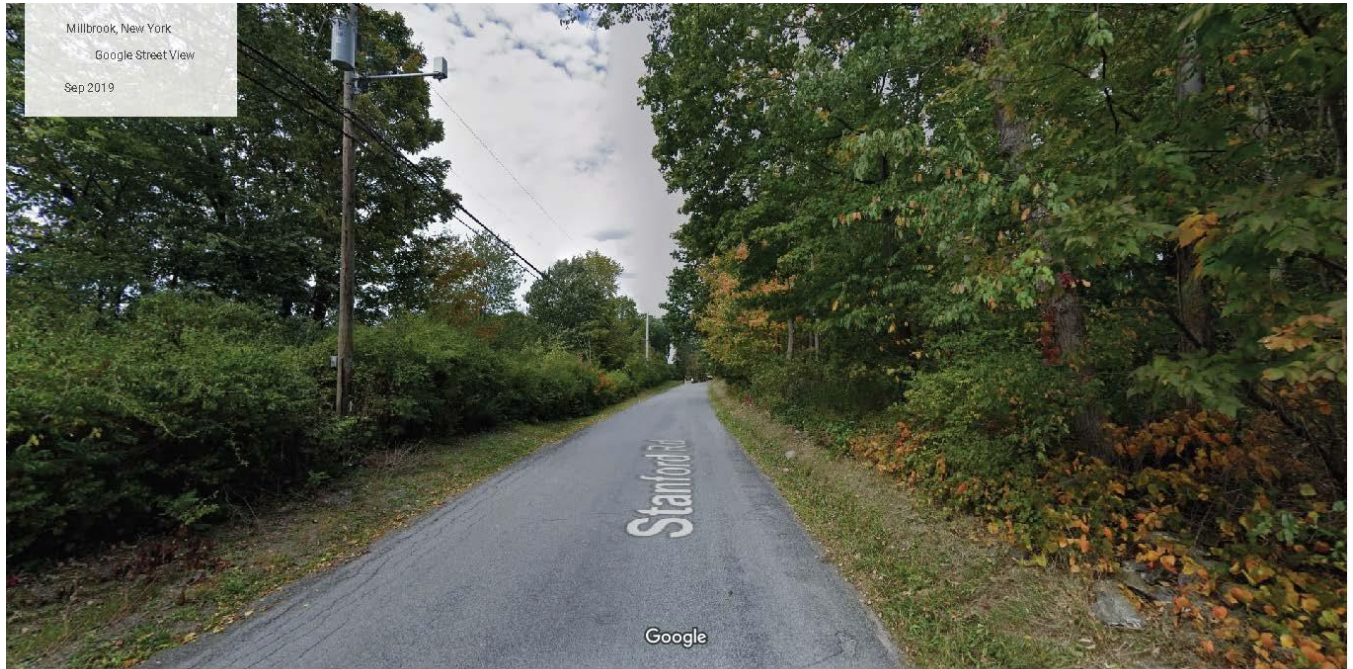
Figure 1: Stanford Rd. view north / southeast of Clear property

The attached photos show that the grades beyond the project site rise quickly on the east side of Stanford Road, to the extent that the Town does not have a full gutter line along the eastern side of the road. Additionally, as shown in Photo 2 below, the Town has installed a new drainage structure which captures storm water on the east side of Stanford Road and carries it, via underground pipe, from the east side of the road to the west side, onto the Clear property. The water flows toward the west, and not toward the east.

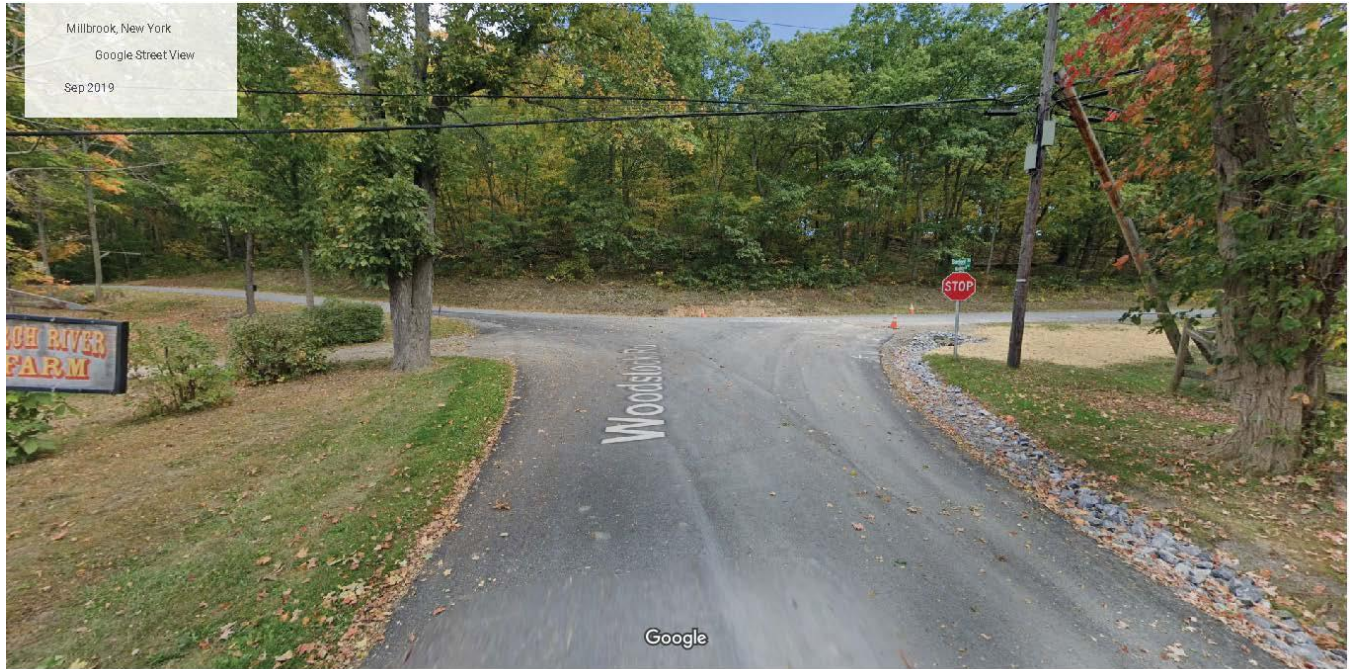
Figure 3: Woodstock Rd. view east to Stanford Rd.

LRC has reviewed available topographic mapping and site photographs for the section of Stanford Road along the Clear frontage. The topography of Stanford Road, and the intersection of Stanford Road and Woodstock Road, shows that Woodstock Road rises in elevation to meet Stanford Road from elevation 592 to elevation 609. Woodstock Road and the project site along its Stanford Road frontage both north and south of Woodstock Road, are well below the elevations of Stanford Road. The project site is below the elevation of Stanford Road, ranging anywhere between 1 and 4 feet below the level of the road.
