***RE: Appeal of Building Permit - Supplemental Submission
Project Site: 749 Stanford Rd., Town of Washington
Tax Map No. 135889-6666-00-727971-0000***

Cross Section Elevations

Appraisal Report

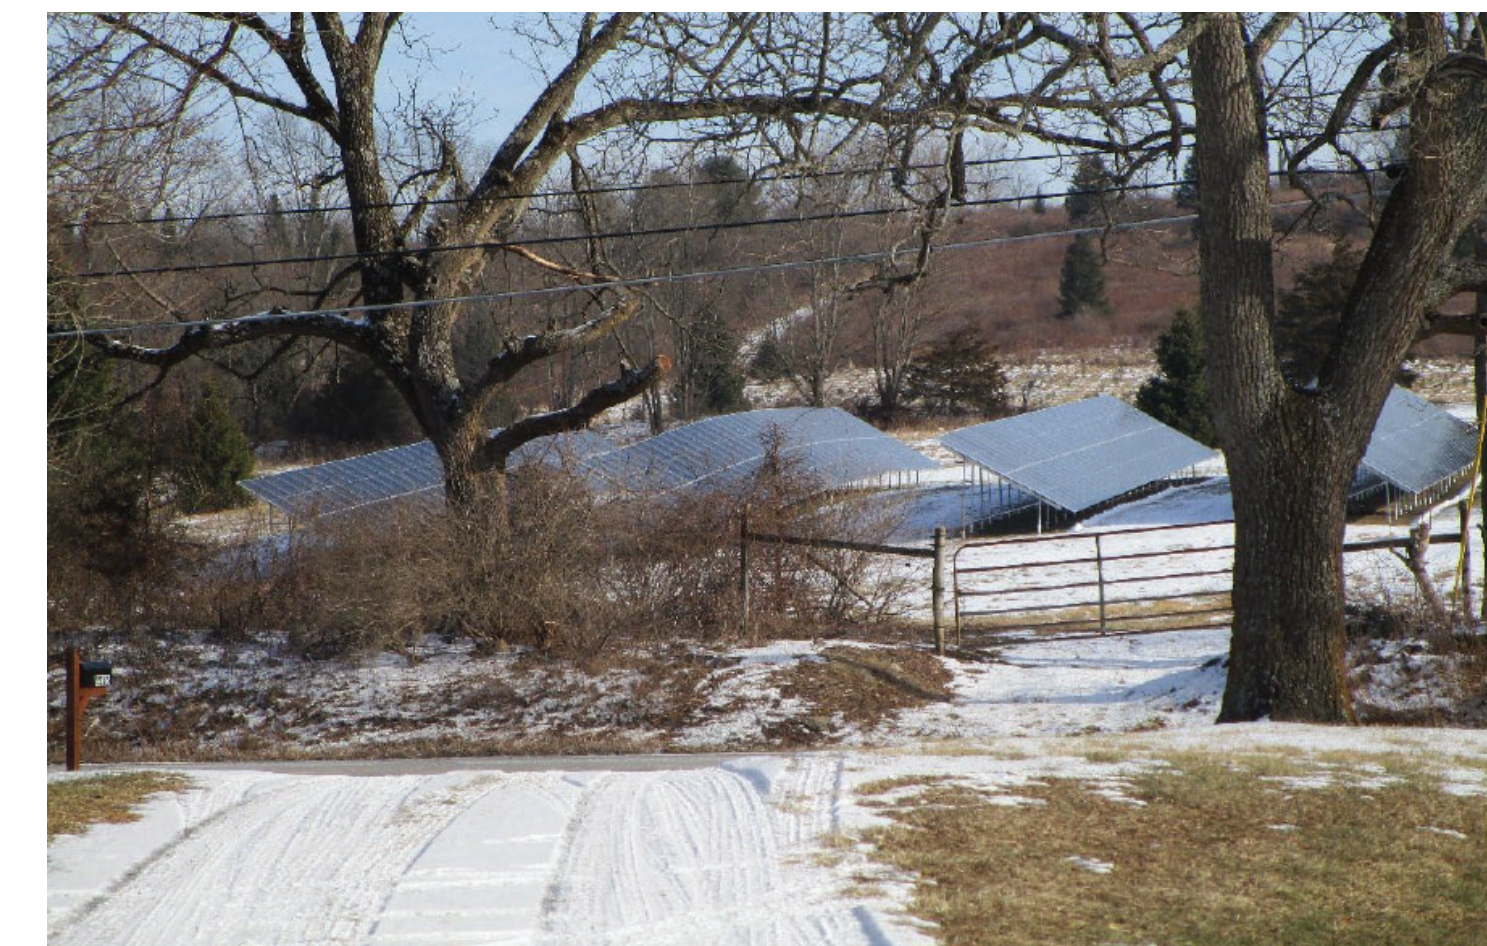
View of Solar Field From Residence Parcel

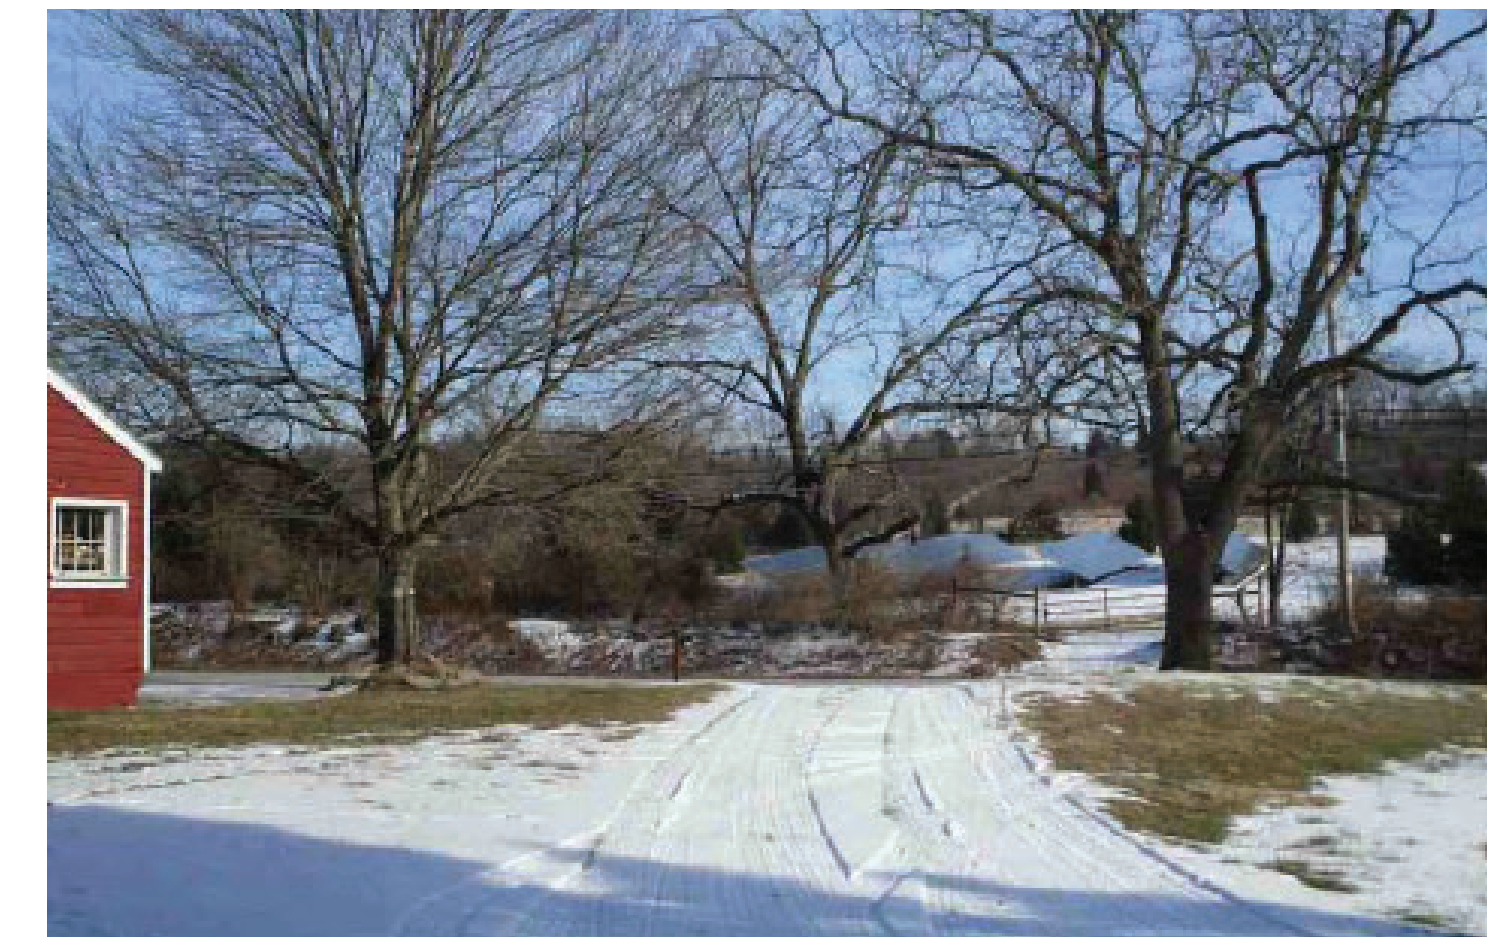
View of Solar Field From Residence Front Entry

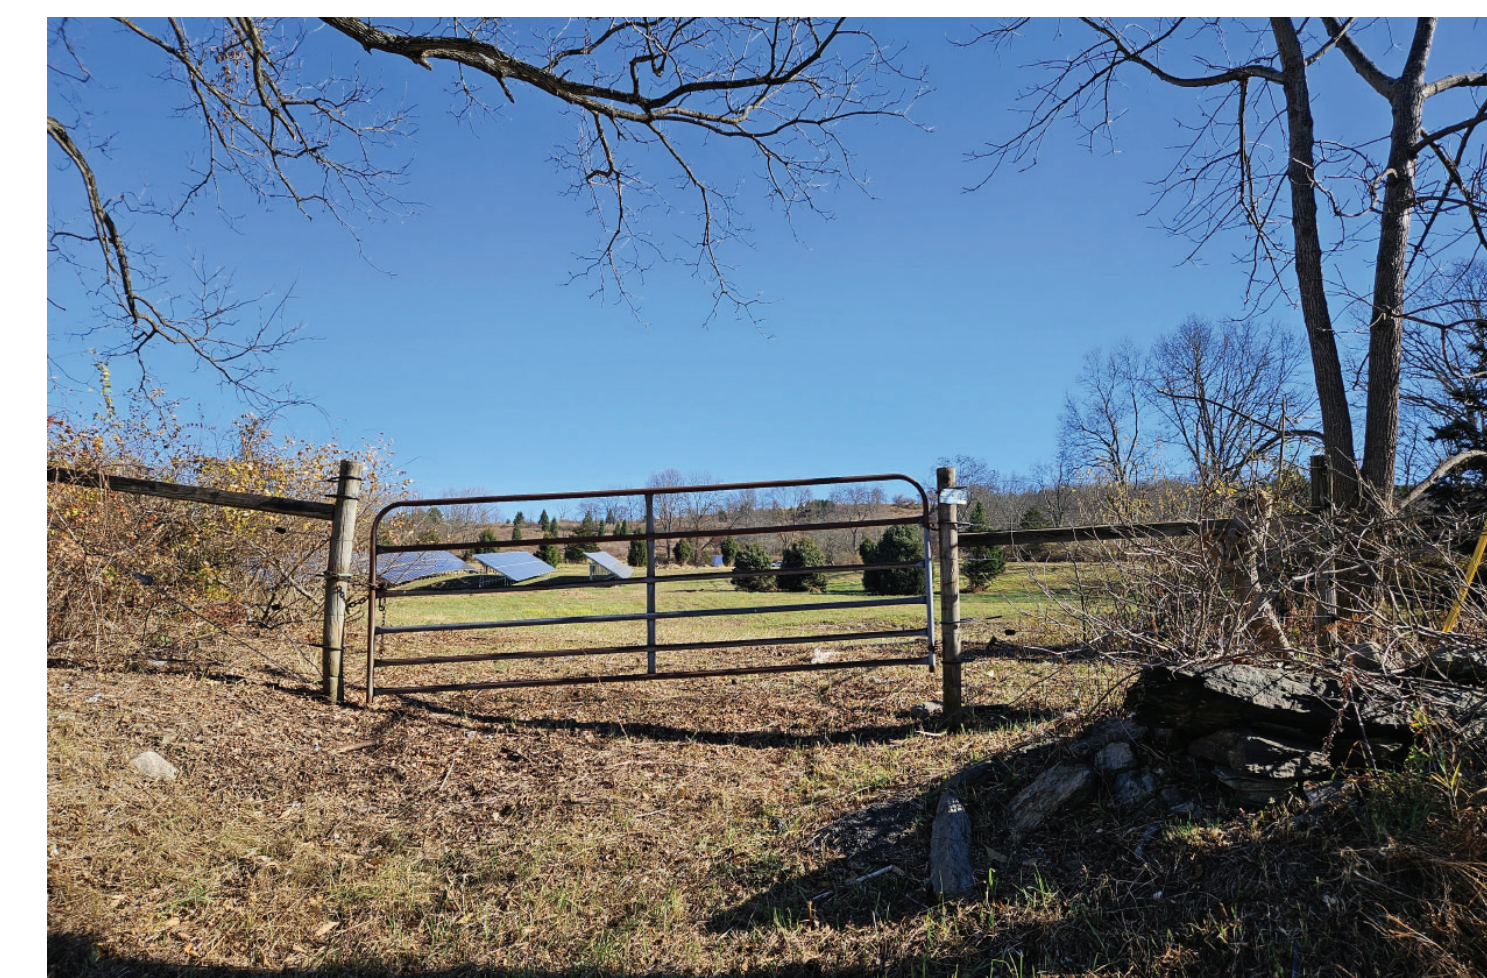
View of Solar Field From Route 82

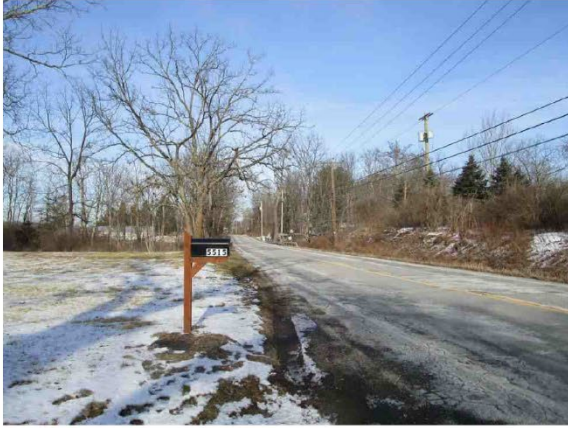
Route 82, facing north; new utility pole at right

Notwithstanding the ZBA's directive, Mr. Pryor has continued his violations of the stop work order. The enclosed photographs show yet *another* new utility pole that was installed on January 13, 2024, along Route 82 to facilitate the installation of the solar panels. **See Enclosed.** In addition to witnessing this construction, the Appellants also witnessed Central Hudson connecting the solar panels to the utility grid. The stop work order applies to all work in furtherance of the solar panel construction, which includes work done by SunCommon and/or Central Hudson. It is hard to believe that the new utility pole and connection to the grid was not coordinated with Mr. Pryor. In addition, SunCommon was at the December 17th ZBA meeting and was made aware of the stop work order and notwithstanding that, has decided to disregard the Town's demands. The Town should take the necessary enforcement steps to ensure that these violations do not continue.

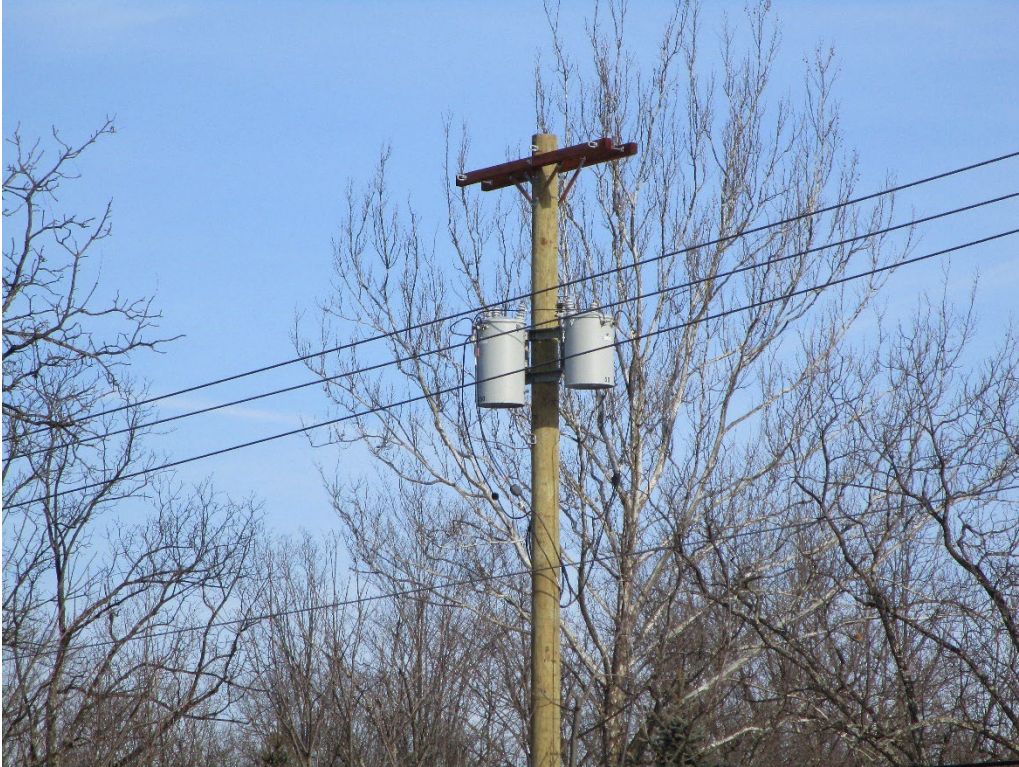
New utility pole erected in view of the subject parcel, across from the barn

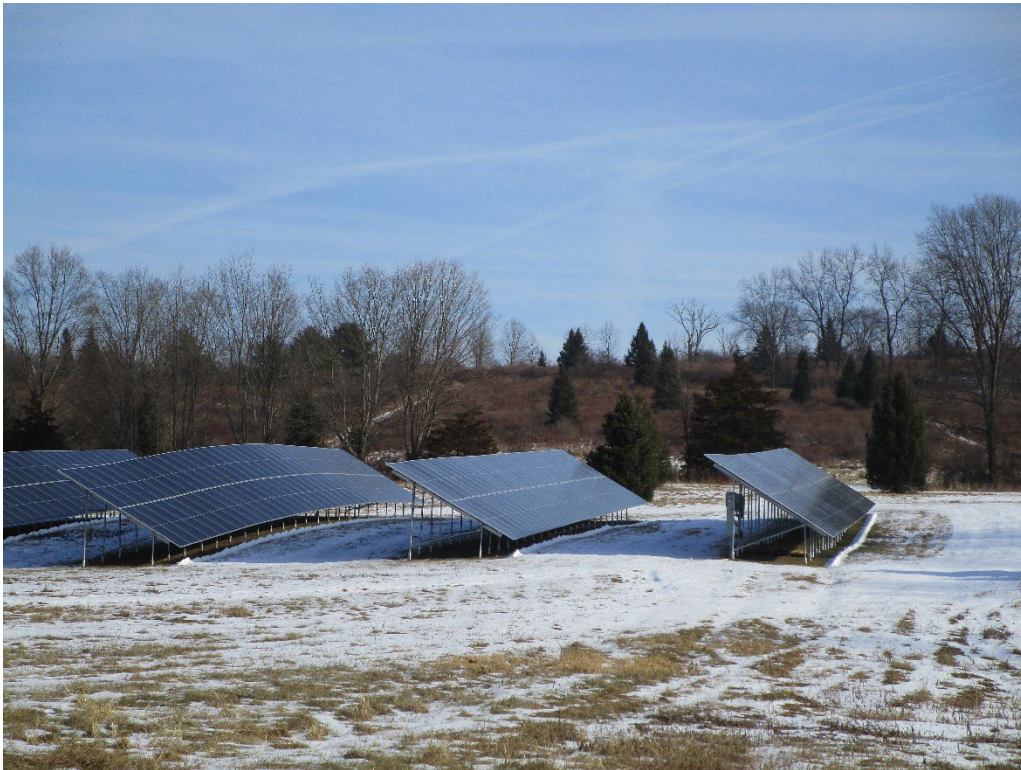
Taken from the road. Google Earth has a measuring function which shows each panel to be about 130 feet long.

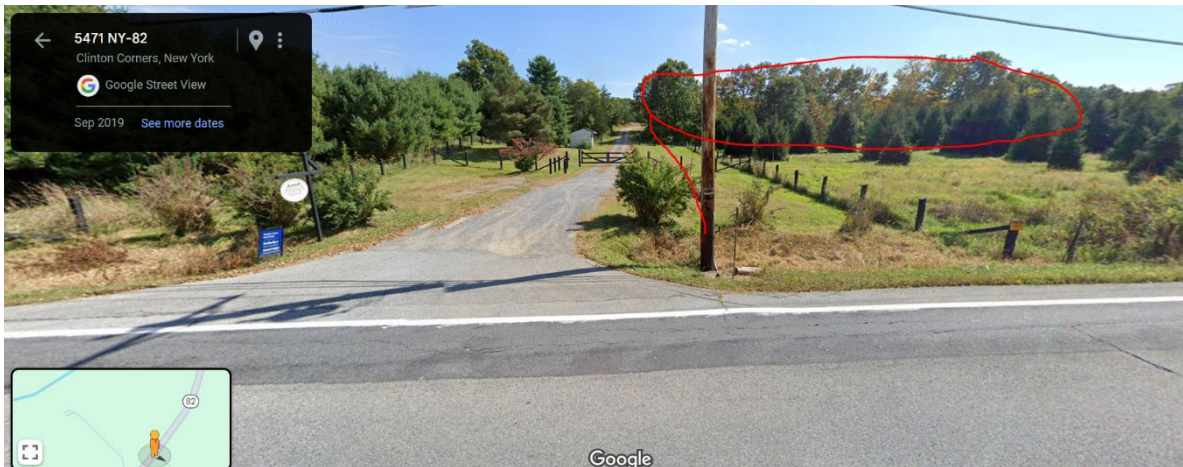
View from Route-82 and location of existing utility pole

Most importantly, at the vehicular access drive, there is an existing utility pole with 3 phase service. This would require minimal development upgrades to provide electrical service to the solar panels. Land directly across the street are open fields. There are no structures immediately visible from the access point from Route-82. This is vital in evaluating the visual impact of the electrical interconnect pole(s). Placement of these pole(s) at the end of the existing driveway would pose no visual impact to the current landscape context in this immediate vicinity.

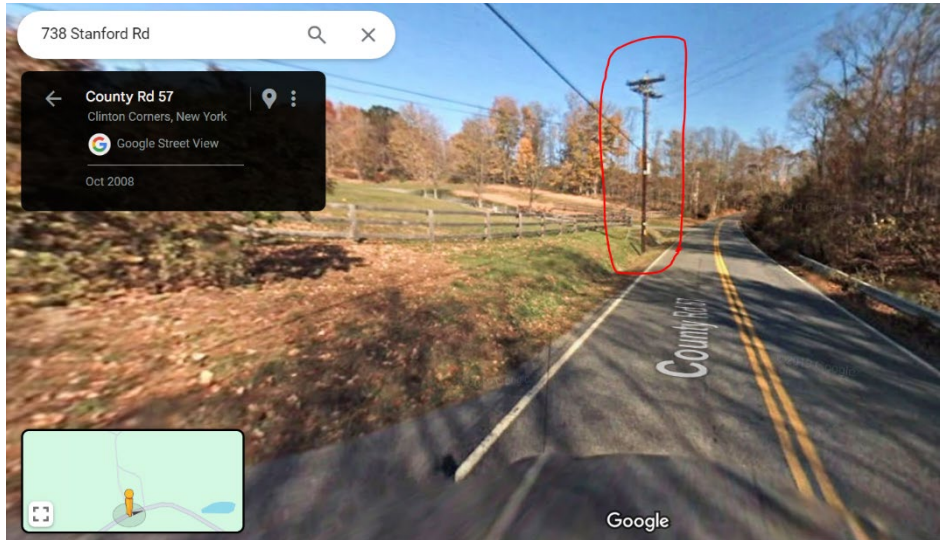
Location of existing utility pole

Most importantly, approximately +/-90 feet from the vehicular access drive, there is an existing utility pole with 3 phase service. This would require minimal development upgrades to provide electrical service to the solar panels. Land directly and adjacent are mature wooded forests. There are no structures immediately visible from the access drive on County Road 57. This is vital in evaluating the visual impact of the electrical interconnect pole(s). Placement of these pole(s) at the end of the existing driveway would pose no impact to the current landscape context in this immediate vicinity.
