Re: *Wetland Delineation*  
*Killearn Road*  
*Town of Washington, Dutchess County, New York*  
*C.T. Male Project No. 23.3211*

Wetland Delineation

Killearn Road

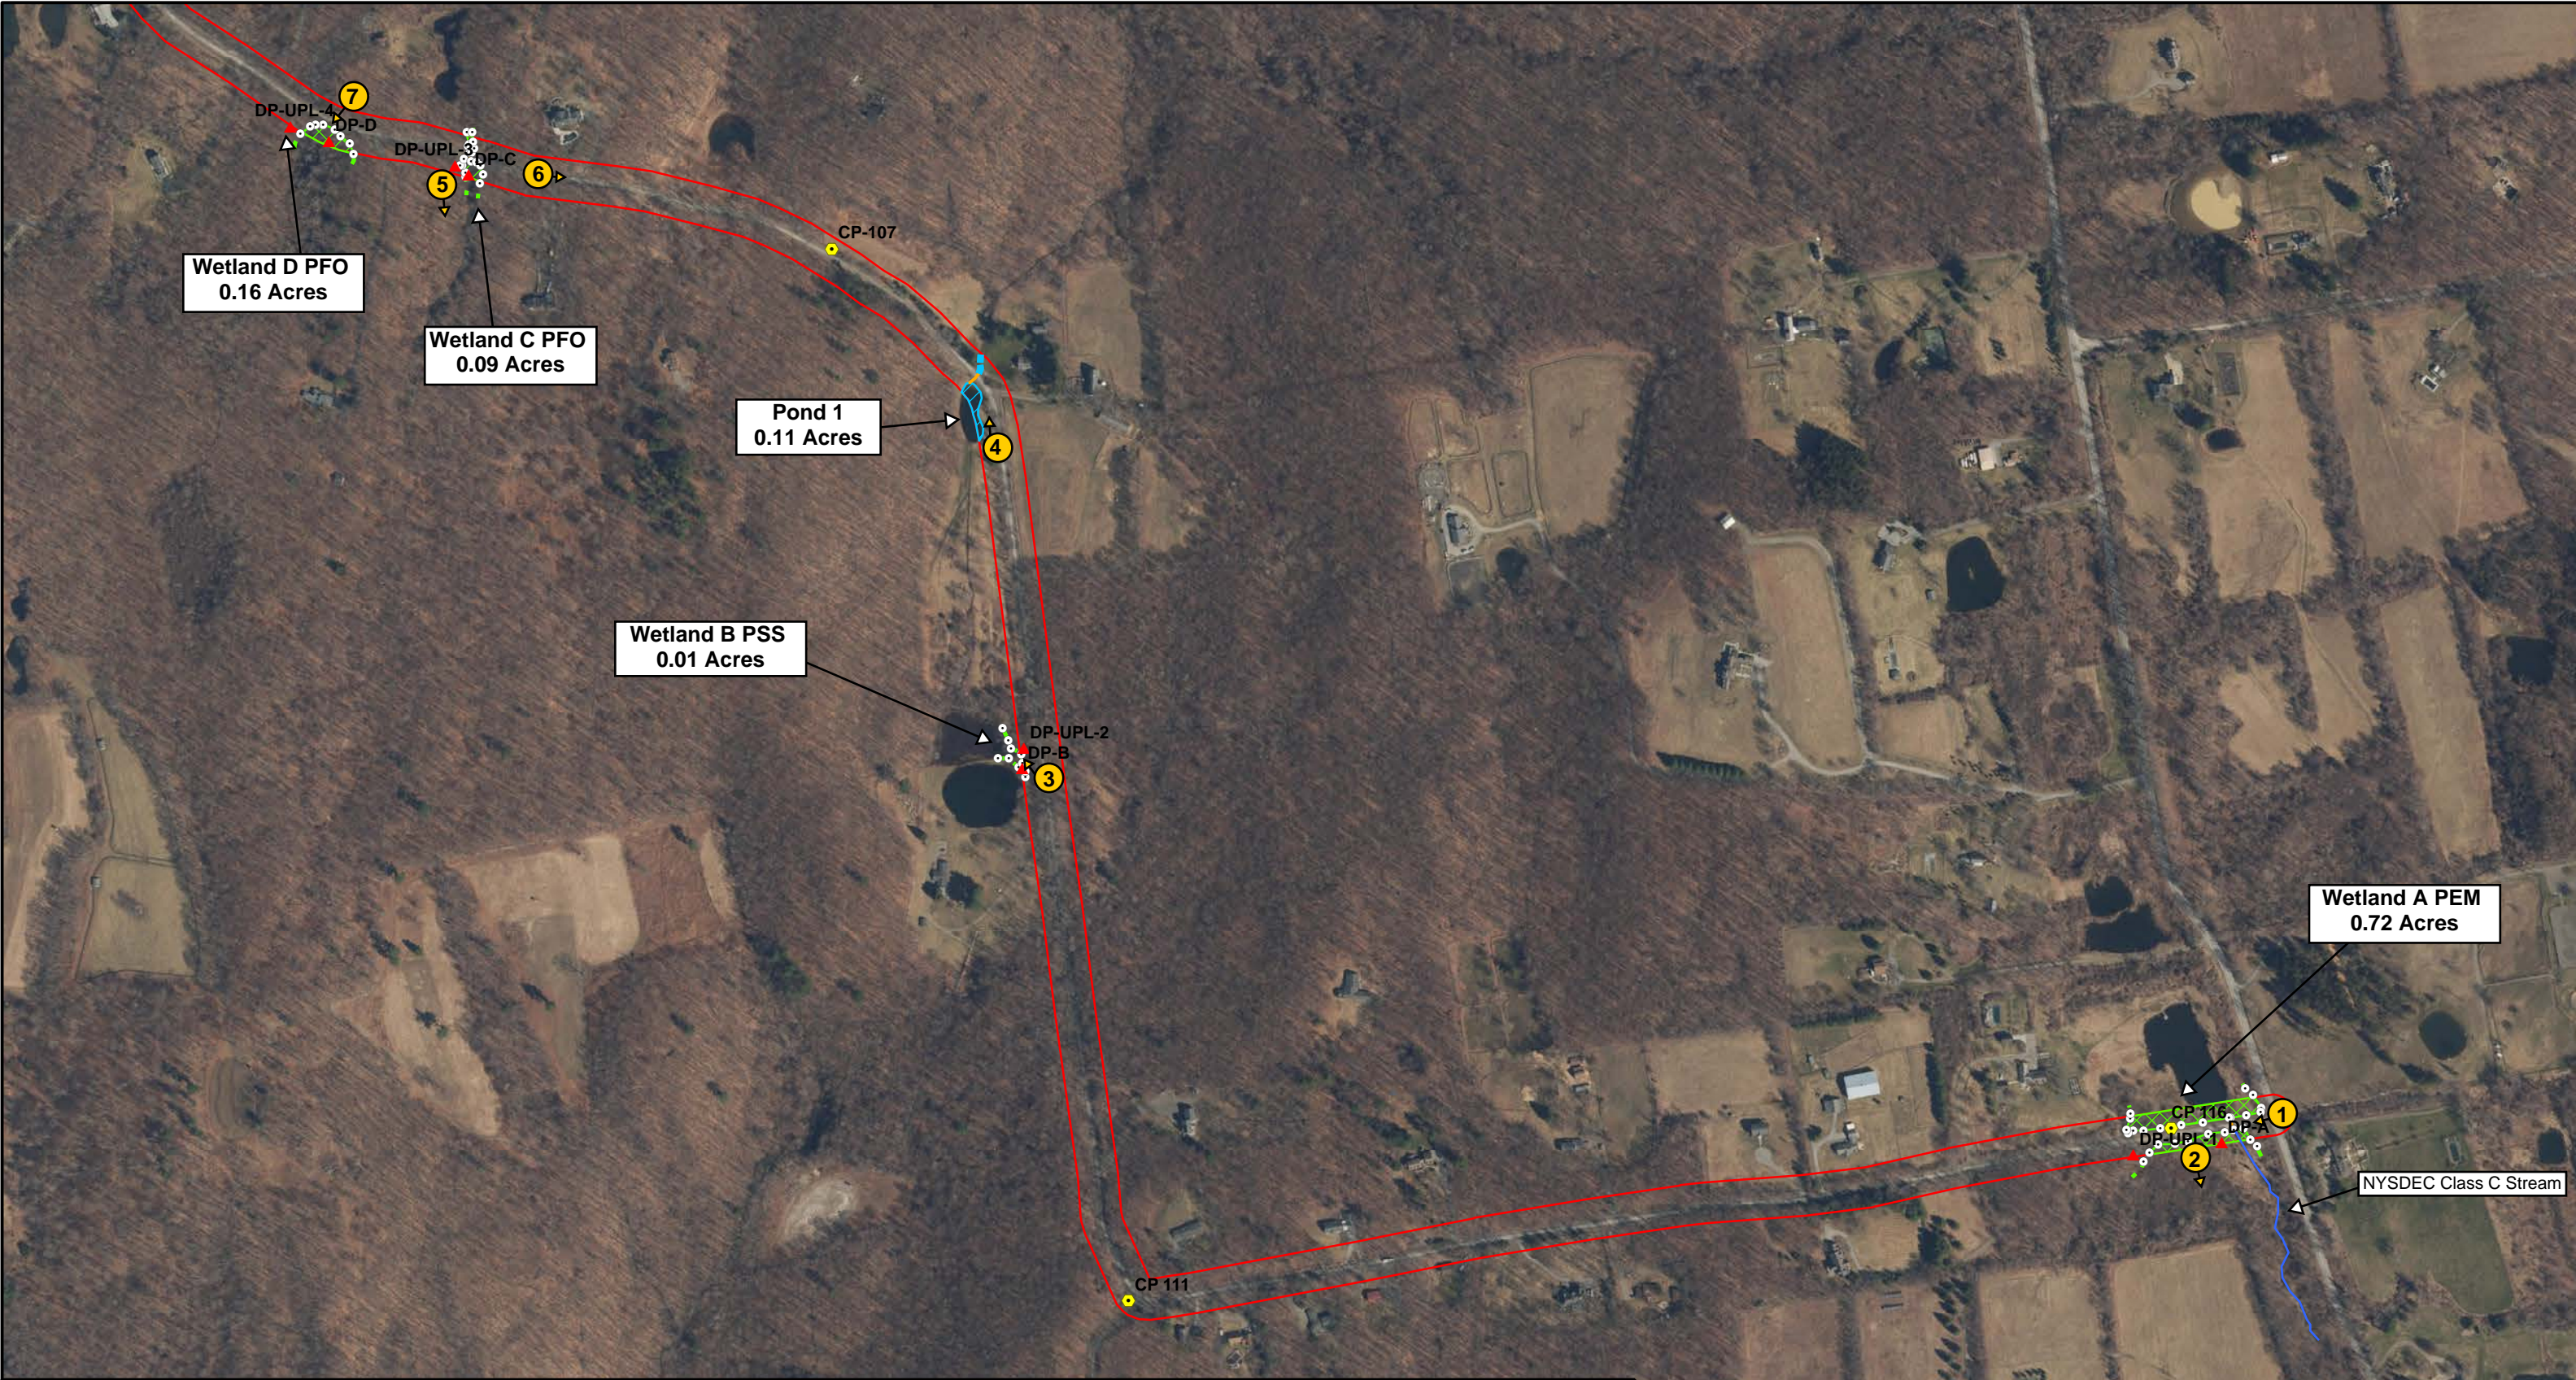
Wetland Delineation Map 1

**Note:** A delineation of wetlands and waterbodies was performed by C.T. Male staff on April 4-7, 2023 in accordance with the 1987 U.S. Army Corps of Engineers (Corps) Wetland Delineation Manual and the Northcentral and Northeast Regional supplement, and the NYSDEC Freshwater Wetland Delineation Manual dated July 1995. Wetland flags were surveyed using a Trimble GEO-7X GPS unit.

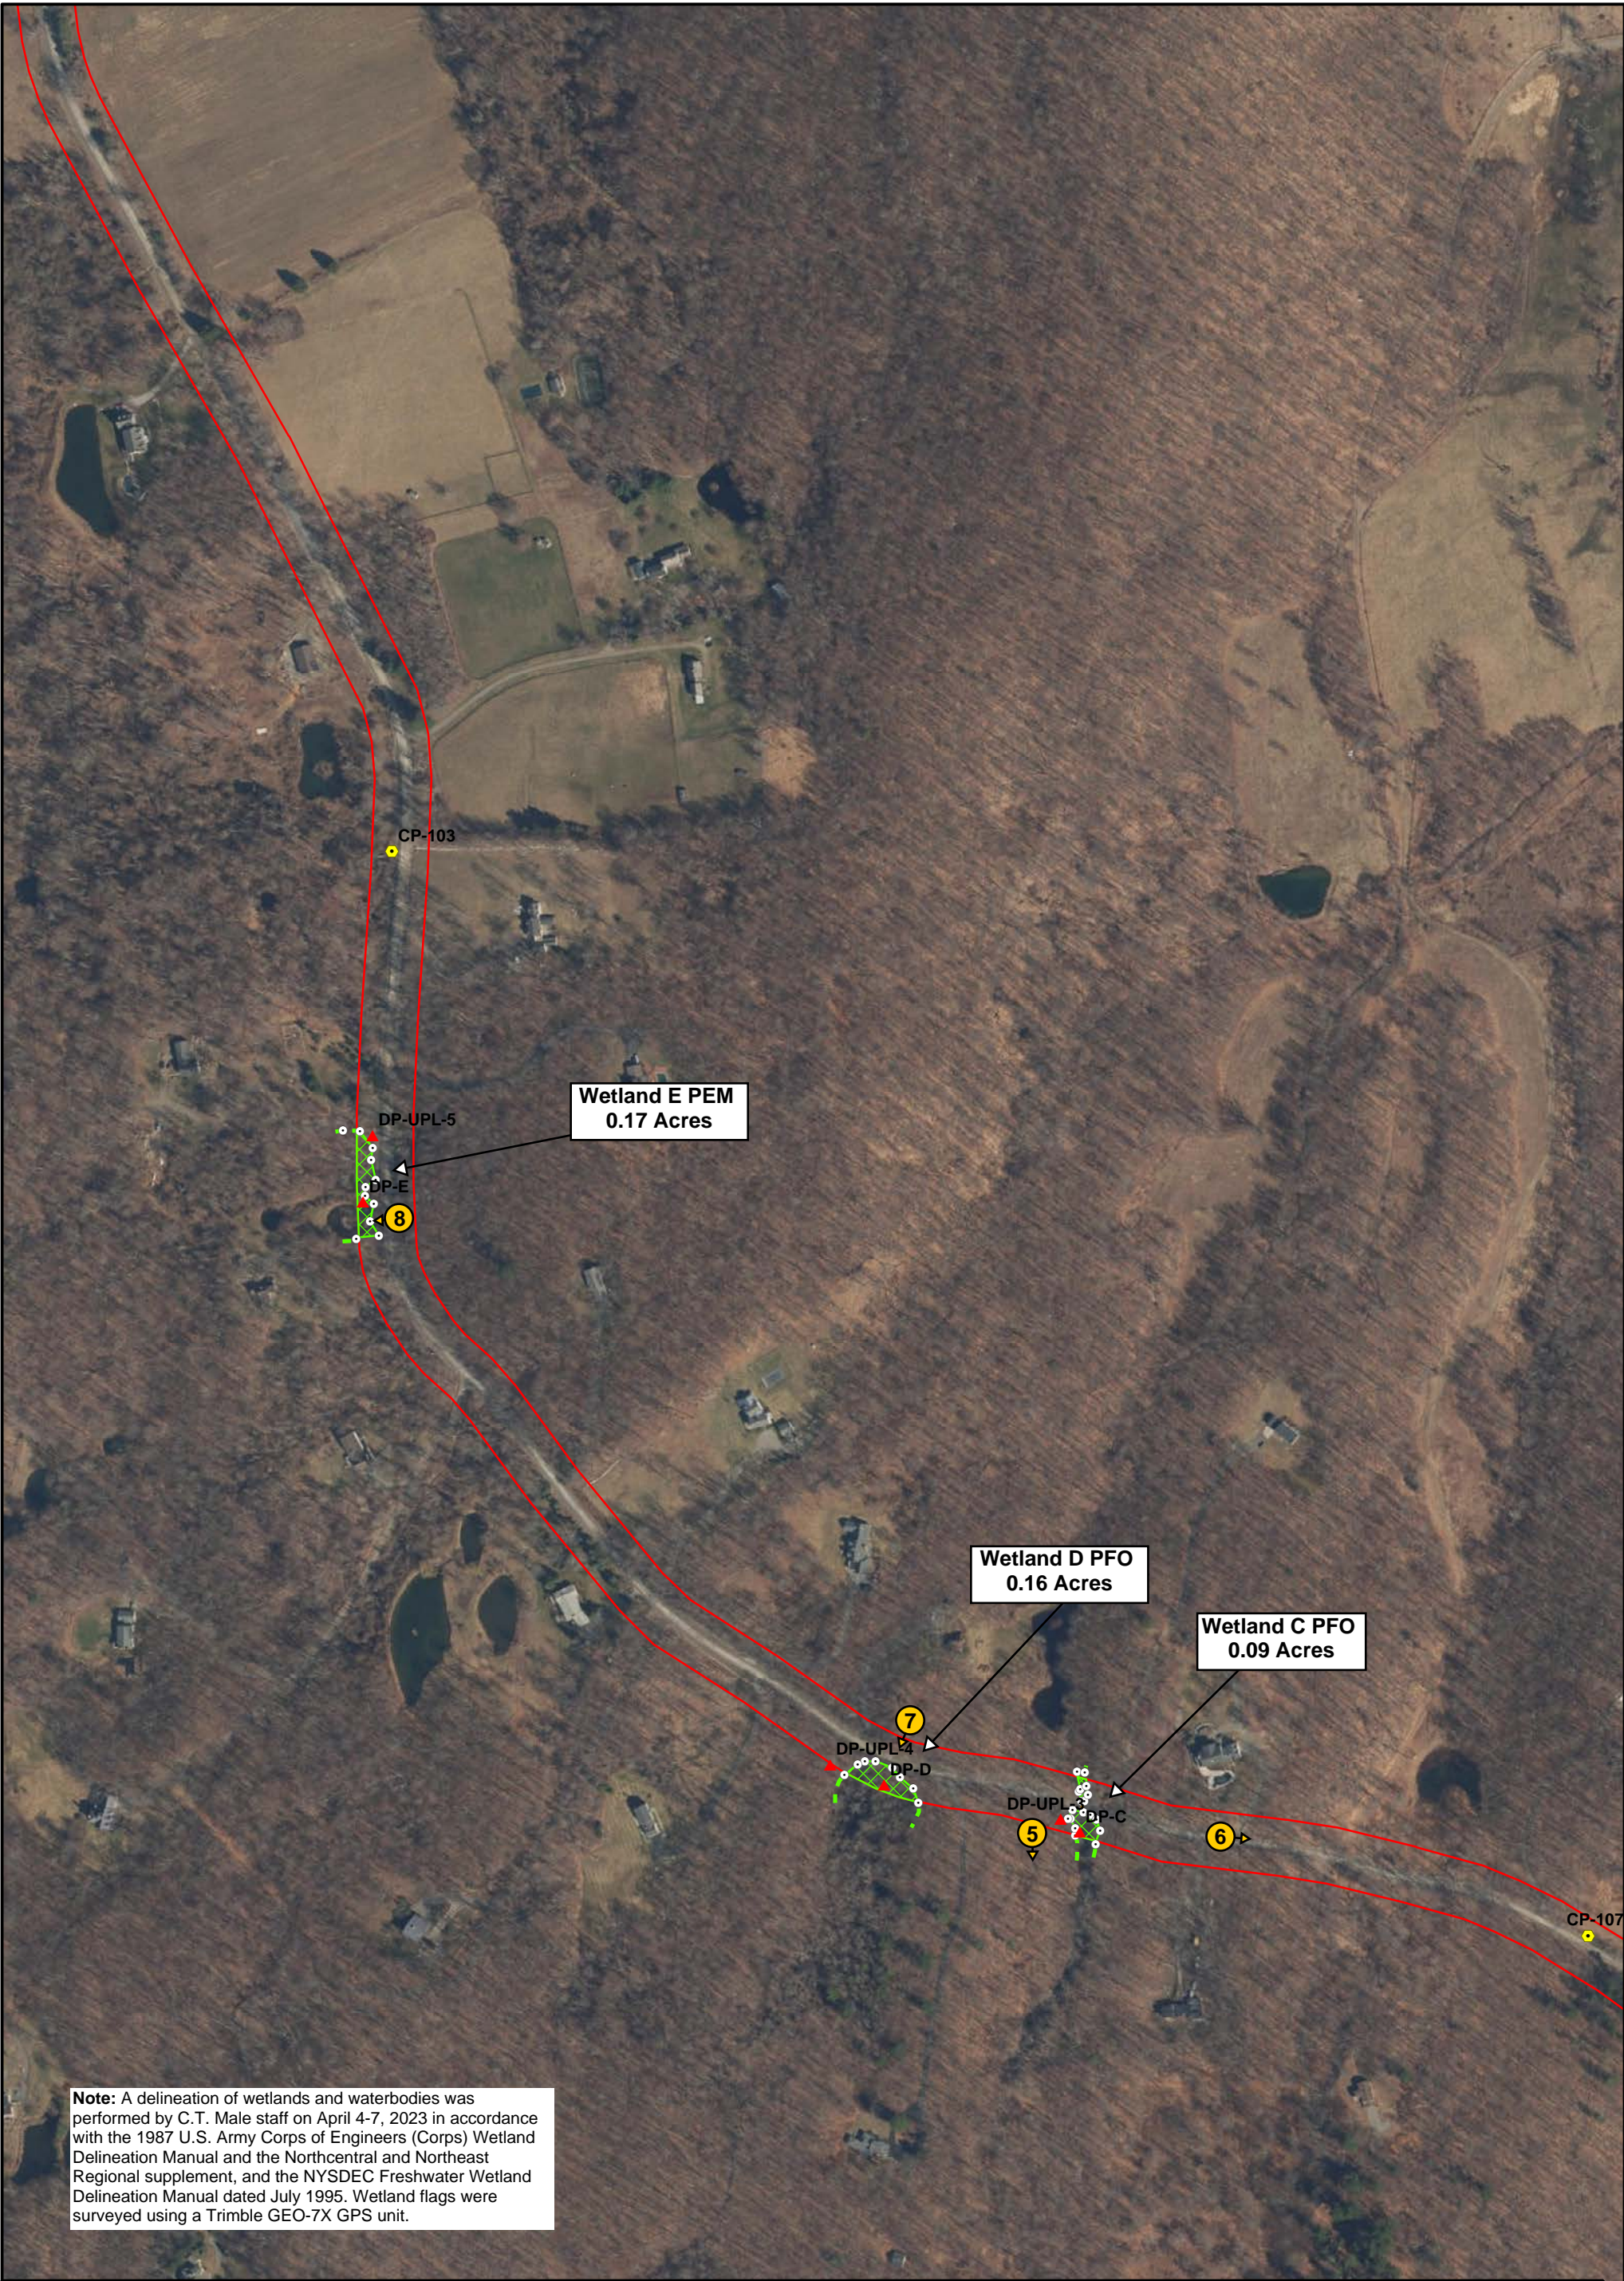
**Killearn Road  
Wetland Delineation Map 2**

**Note:** A delineation of wetlands and waterbodies was performed by C.T. Male staff on April 4-7, 2023 in accordance with the 1987 U.S. Army Corps of Engineers (Corps) Wetland Delineation Manual and the Northcentral and Northeast Regional supplement, and the NYSDEC Freshwater Wetland Delineation Manual dated July 1995. Wetland flags were surveyed using a Trimble GEO-7X GPS unit.

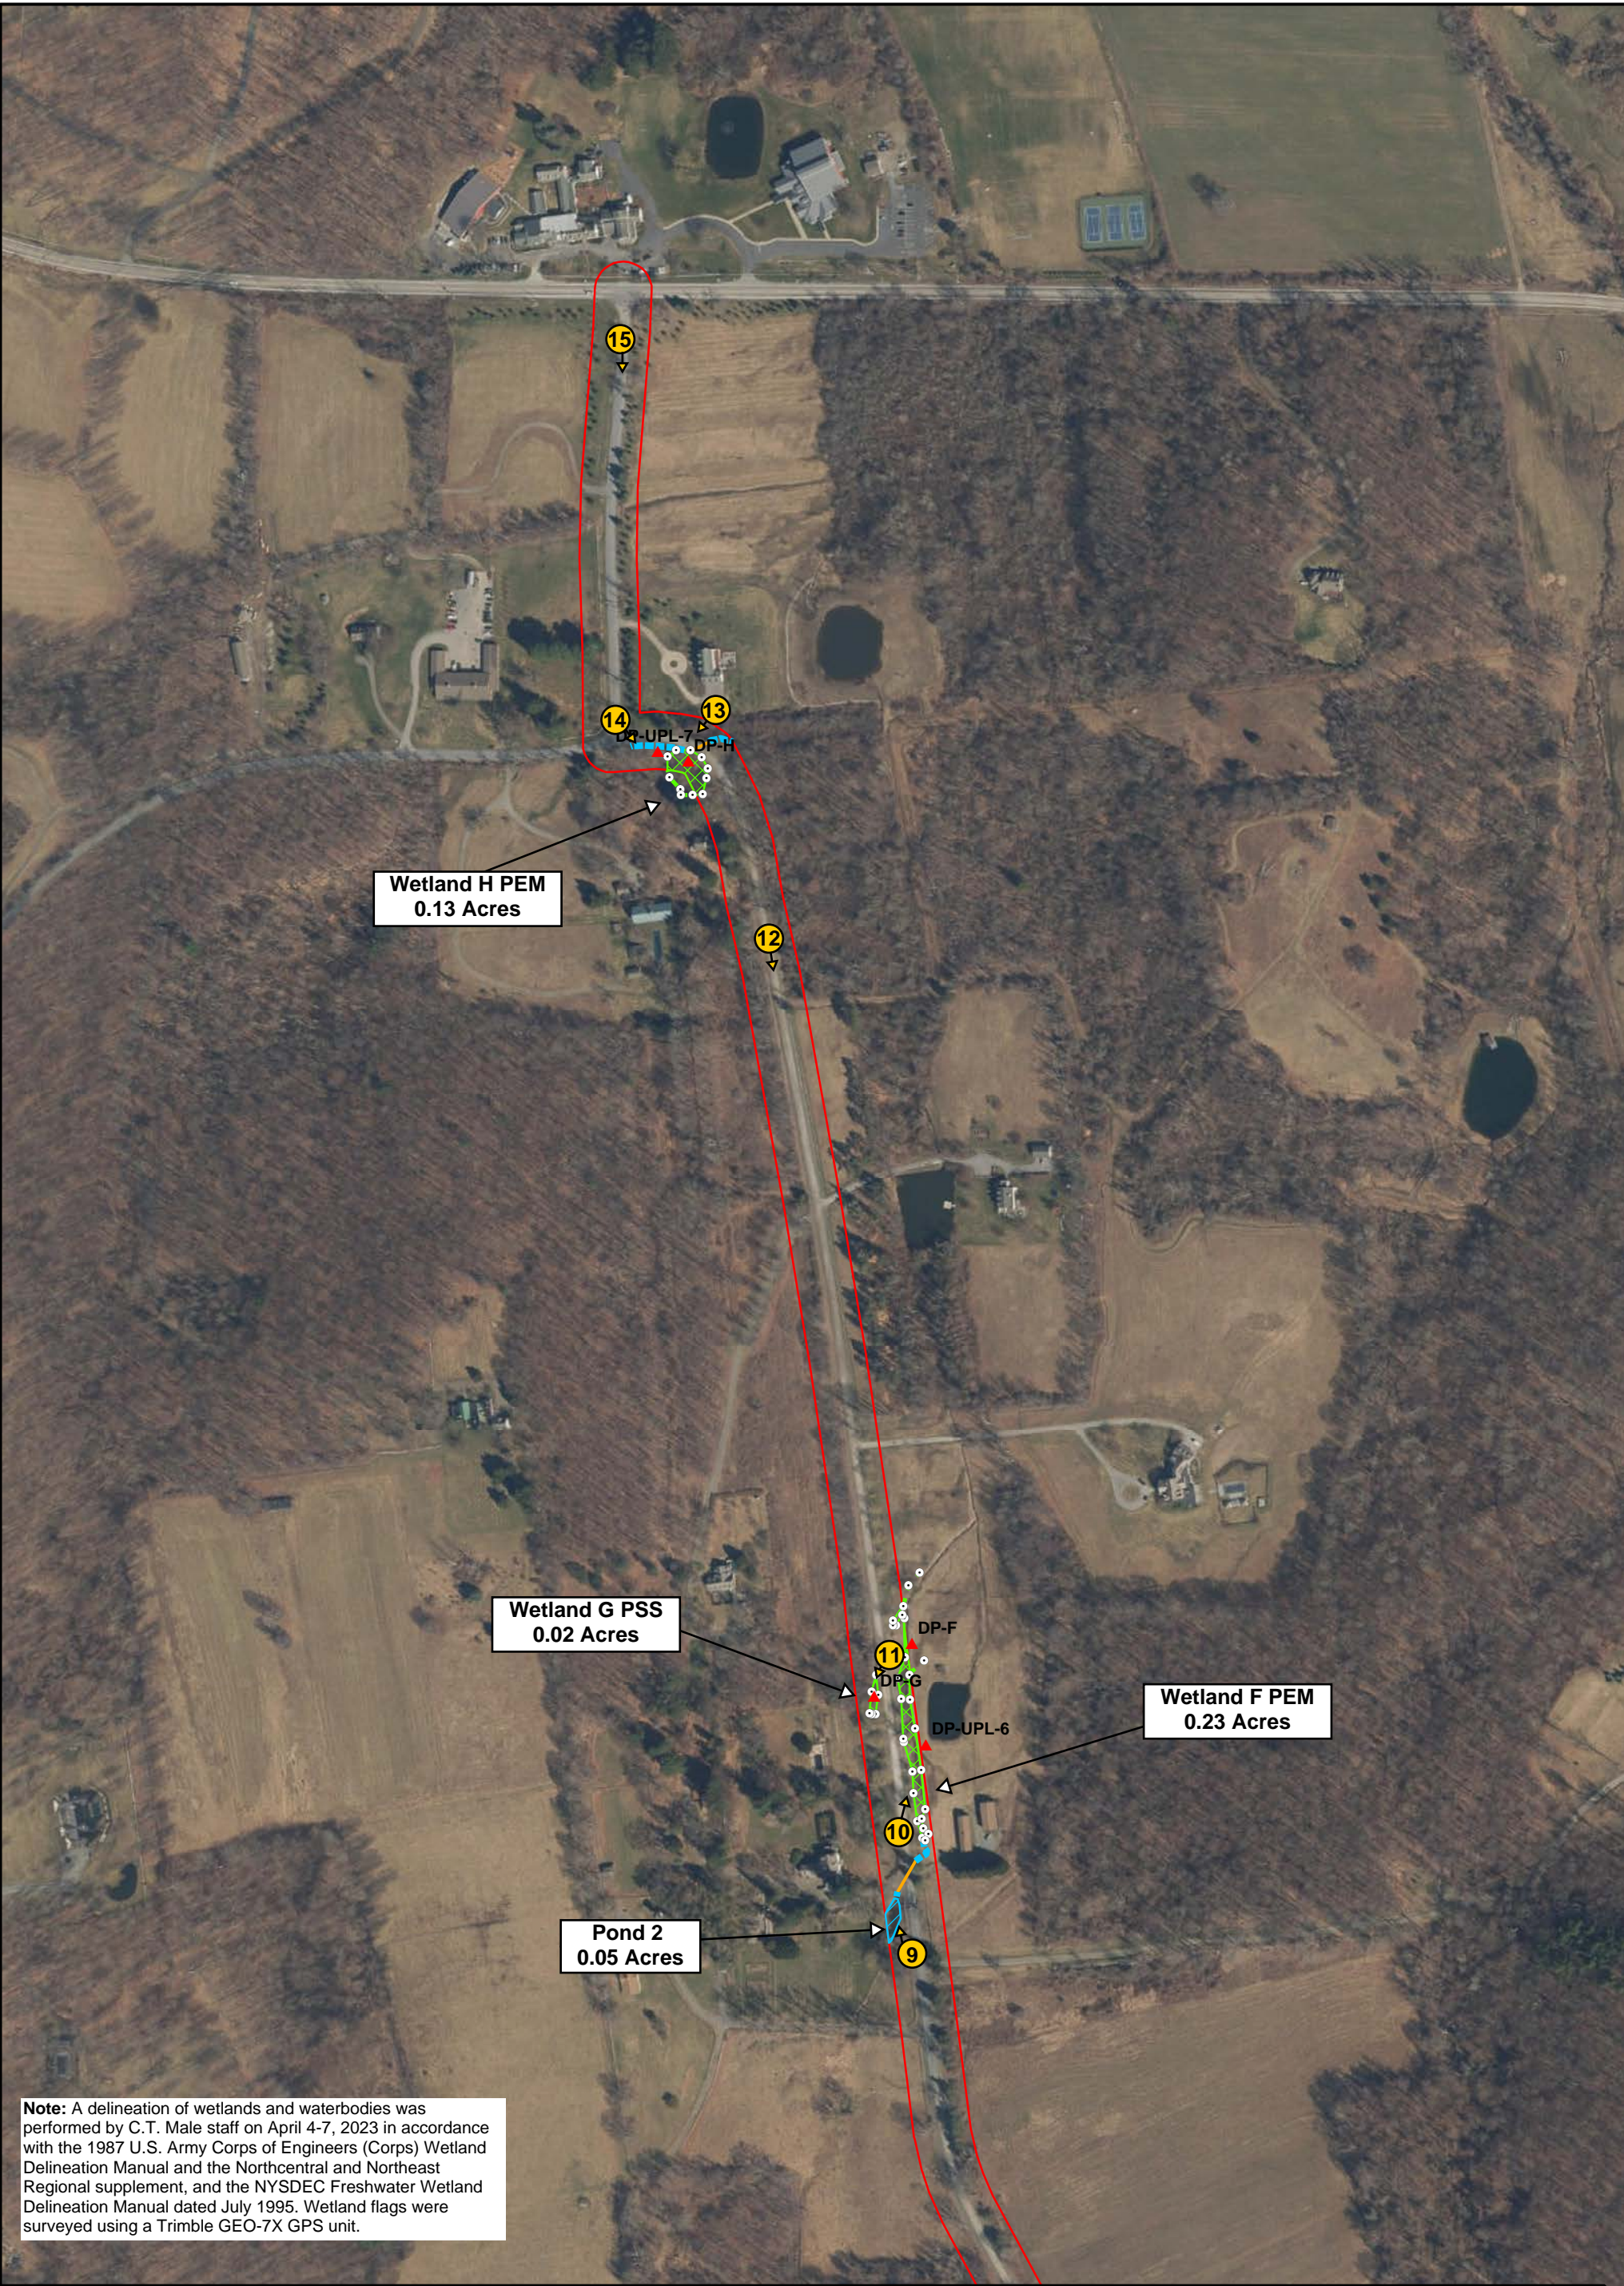
**Killearn Road**  
**Wetland Delineation Map 3**

**Note:** A delineation of wetlands and waterbodies was performed by C.T. Male staff on April 4-7, 2023 in accordance with the 1987 U.S. Army Corps of Engineers (Corps) Wetland Delineation Manual and the Northcentral and Northeast Regional supplement, and the NYSDEC Freshwater Wetland Delineation Manual dated July 1995. Wetland flags were surveyed using a Trimble GEO-7X GPS unit.

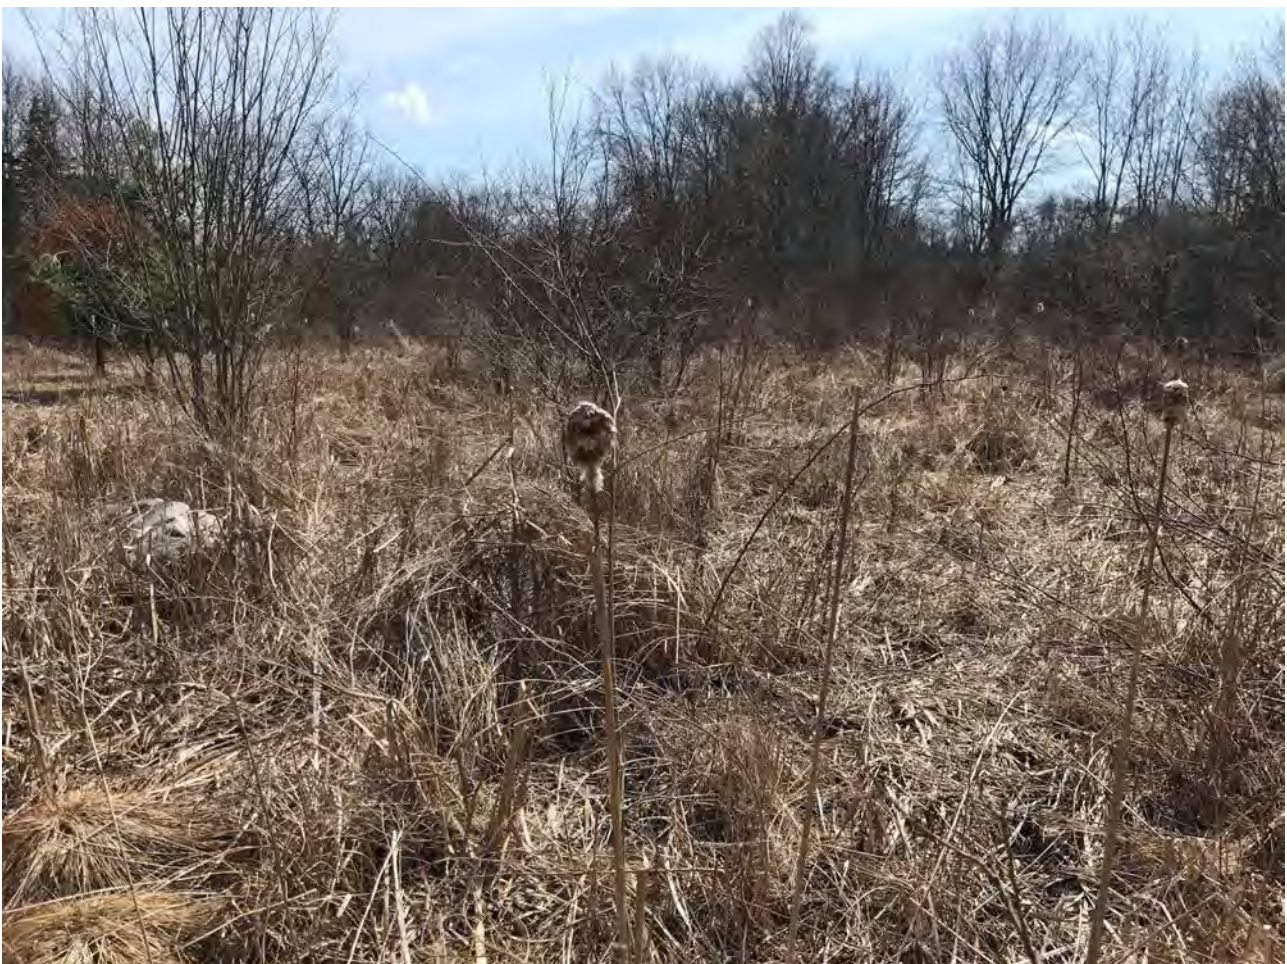
**Wetland A** is a Palustrine Emergent (PEM) wetland located in the southeastern portion of the site covering approximately 0.72 acres on the north and south side of Killearn Road. Several indicators of wetland hydrology were observed including high water table, saturation, geomorphic position, and FAC-neutral test. Wetland A is dominated by several species of hydrophytic vegetation including weeping willow (*Salix babylonica*), purple willow (*Salix purpurea*), narrow-leaf cattail (*Typha angustifolia*), and tussock sedge (*Carex stricta*). Hydric silt-loam soils were also observed.

Wetland A receives drainage offsite from a pond and a perennial stream (PS-1) and drains offsite to the same stream. Wetland A is assumed to be under the jurisdiction of the Corps due to observed surface water connections to other resources.

2. Wetland A viewed south

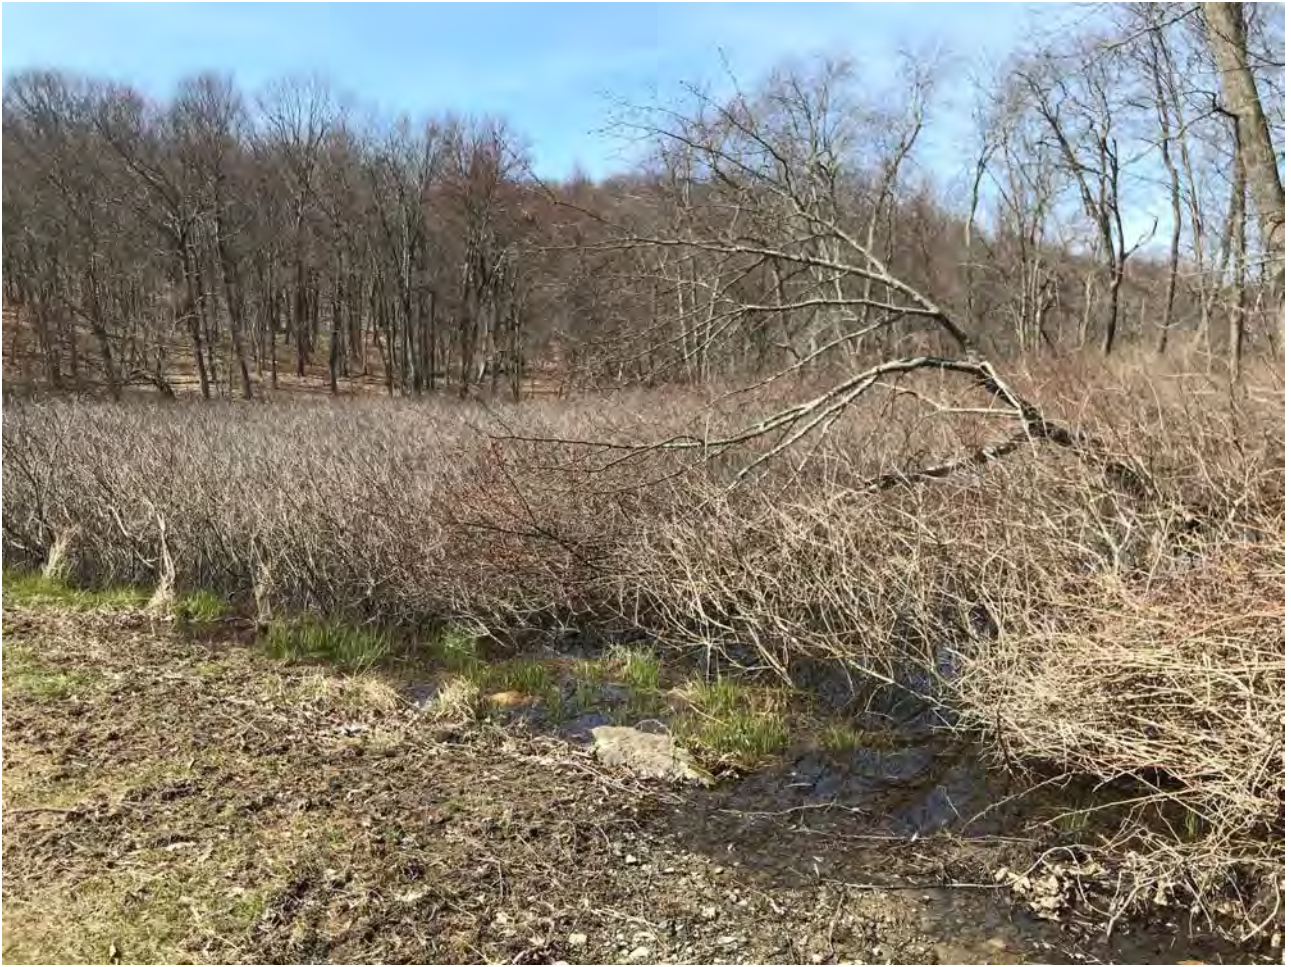
**Wetland B** is a Palustrine Scrub-shrub (PSS)/vernal pool wetland covering approximately 0.01 acres within the southern portion of the site. Several indicators of wetland hydrology were observed including surface water, high water table, saturation, inundation visible on aerial imagery, aquatic fauna, geomorphic position, and FAC-neutral test. Wetland B is dominated by several species of hydrophytic vegetation including speckled alder (*Alnus incana*), and tussock sedge. Hydric silt loam soils were also observed.

Wetland B receives drainage from an offsite residential pond with the majority of its area (>1 acre) occurring offsite and drains offsite to Pond 1. Faerie shrimp (*Branchinecta lynchi*), an obligate vernal pool species, were also observed. Wetland B is assumed to be under the jurisdiction of the Corps due to its overall size and likely offsite connections to other resources.

3. Wetland B viewed northwest

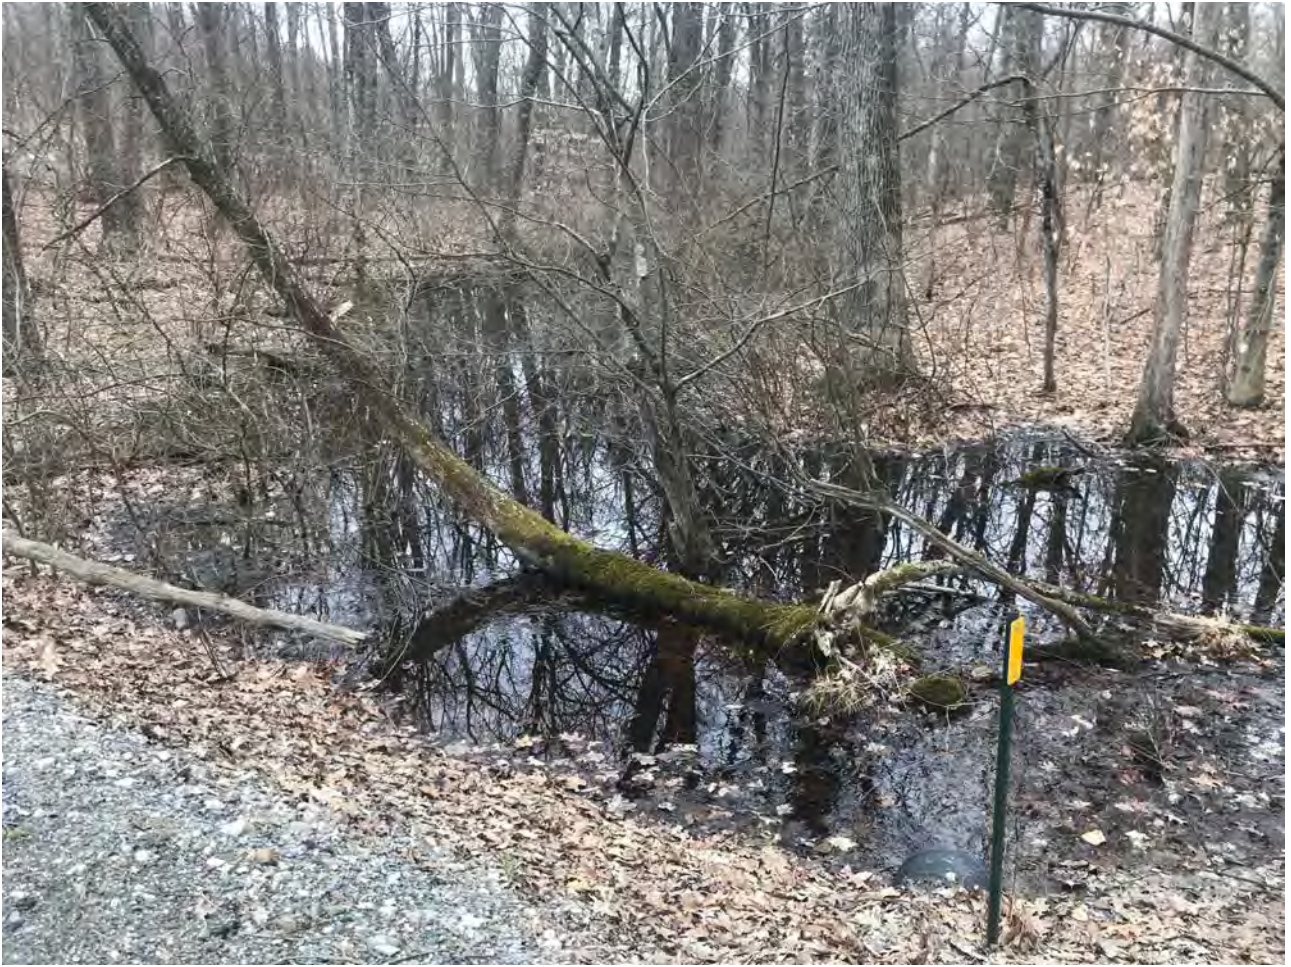
**Wetland C** is a Palustrine Forested (PFO) wetland that covers approximately 0.09 acres within the southern portion of the site along the east and west side of Killearn Road. Several indicators of wetland hydrology were observed including surface water, high water table, saturation, moss trim lines, geomorphic position, and FAC-neutral test. Wetland C is dominated by several species of hydrophytic vegetation including red maple (*Acer rubrum*), dwarf honeysuckle (*Lonicera xylosteum*), and skunk cabbage (*Symplocarpus foetidus*). Hydric muck and silt loam soils were also observed.

5. Wetland C viewed west

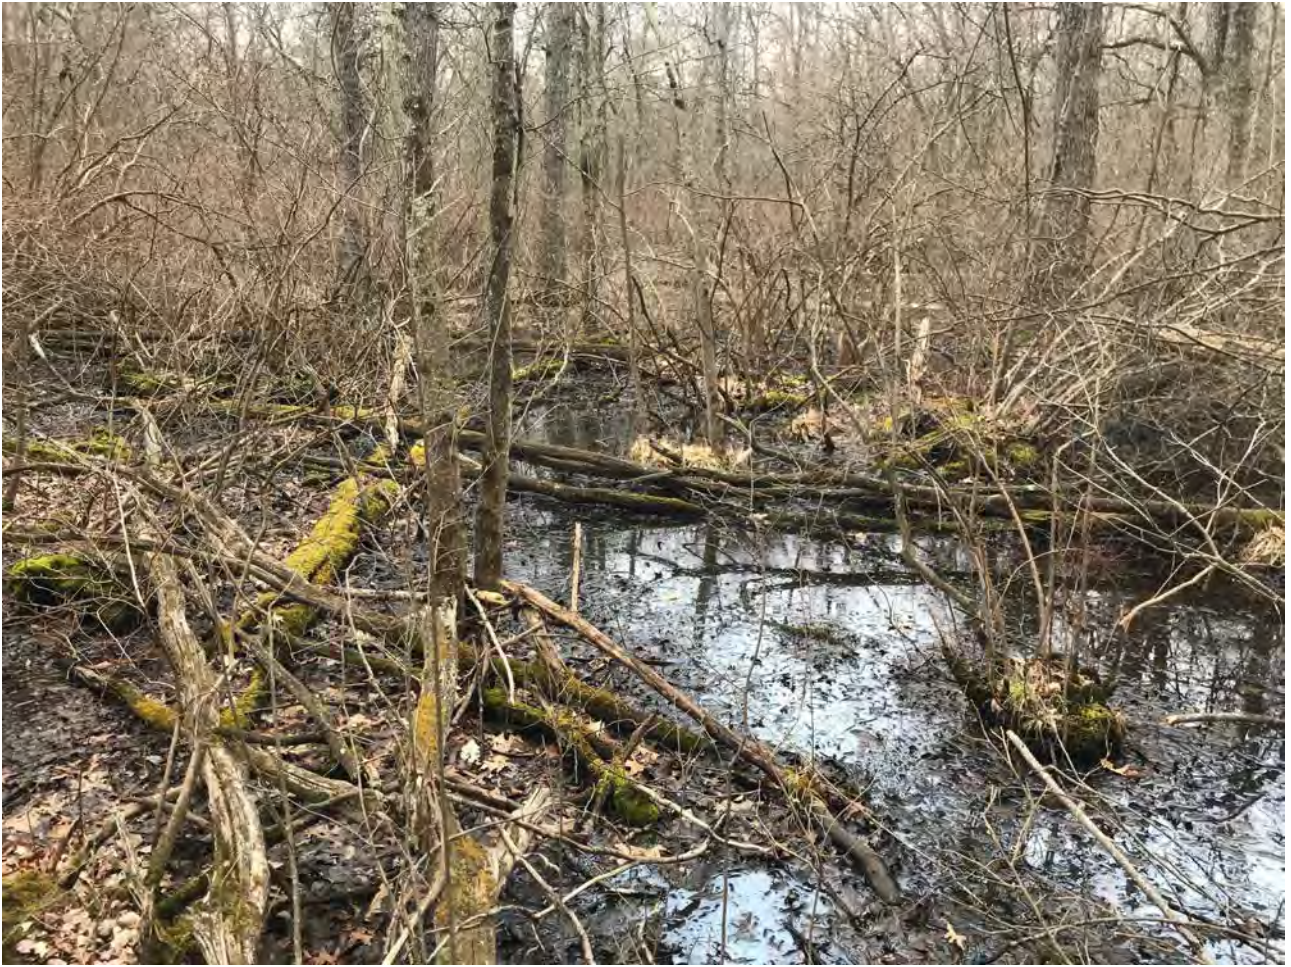
**Wetland D** is a PFO wetland that covers approximately 0.16 acres in the southern portion of the site on the west side of Killearn Road and extends offsite to the west. Several indicators of wetland hydrology were observed including surface water, high water table, saturation, moss trim lines, geomorphic position, and FAC-neutral test. Wetland D is dominated by several species of hydrophytic vegetation including red maple, dwarf honeysuckle, tussock sedge, and skink cabbage. Hydric muck and silt loam soils were also observed.

7. Wetland D viewed west

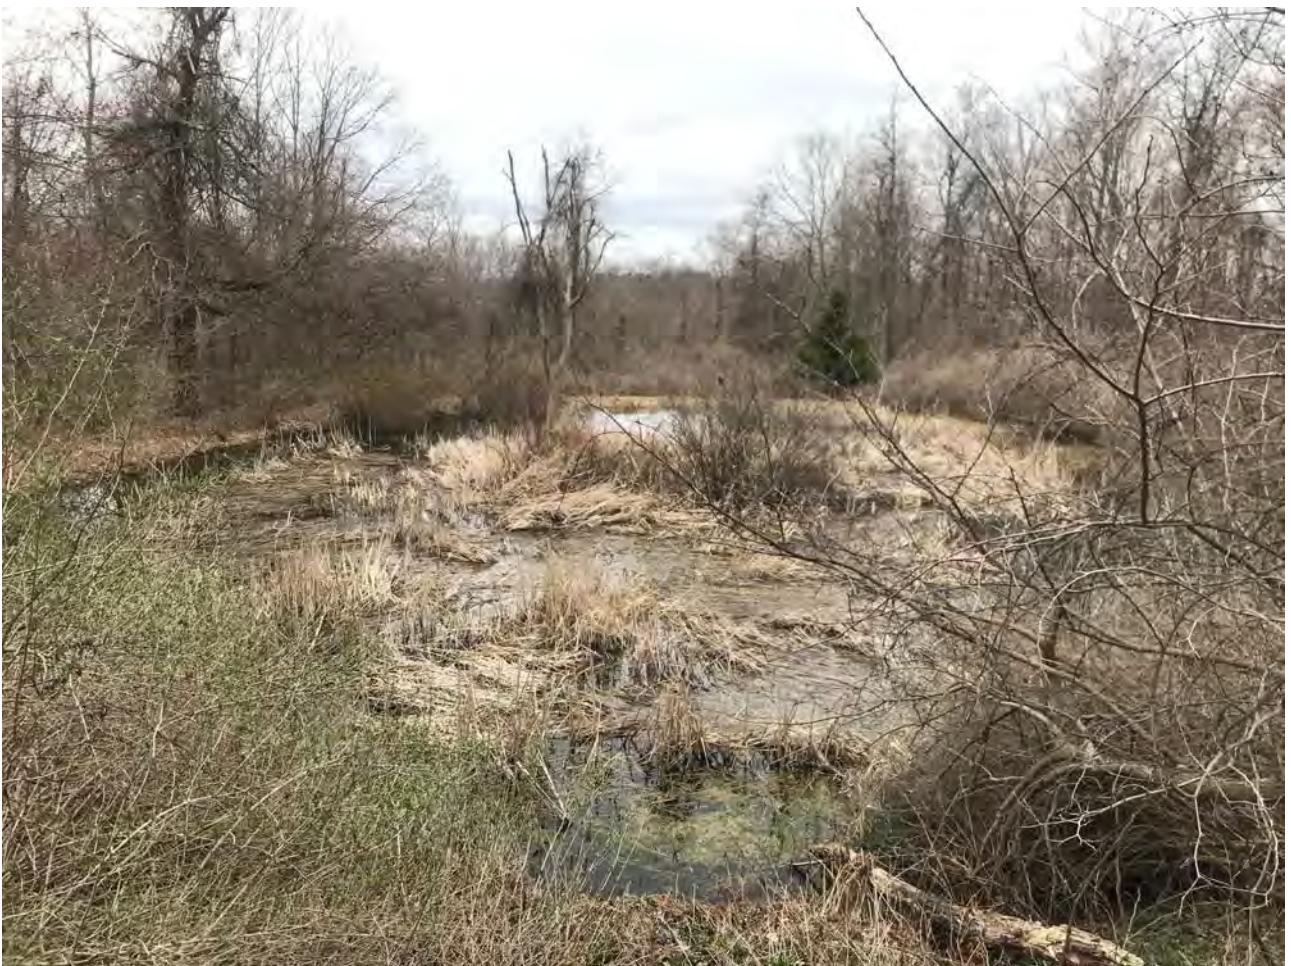
**Wetland E** is a PEM wetland covering approximately 0.17 acres within the central portion of the site on the west side of Killearn Road. Several indicators of wetland hydrology were observed including surface water, high water table, saturation, inundation visible on aerial imagery, and geomorphic position. Wetland E is dominated by several species of hydrophytic vegetation including narrow-leaf cattail. Hydric silt-loam soils were also observed.

Wetland E receives drainage from adjacent uplands and appears to be hydrologically isolated with no observed surface water outlets. Wetland C is potentially non-jurisdictional as an isolated wetland.

8. Wetland E viewed west

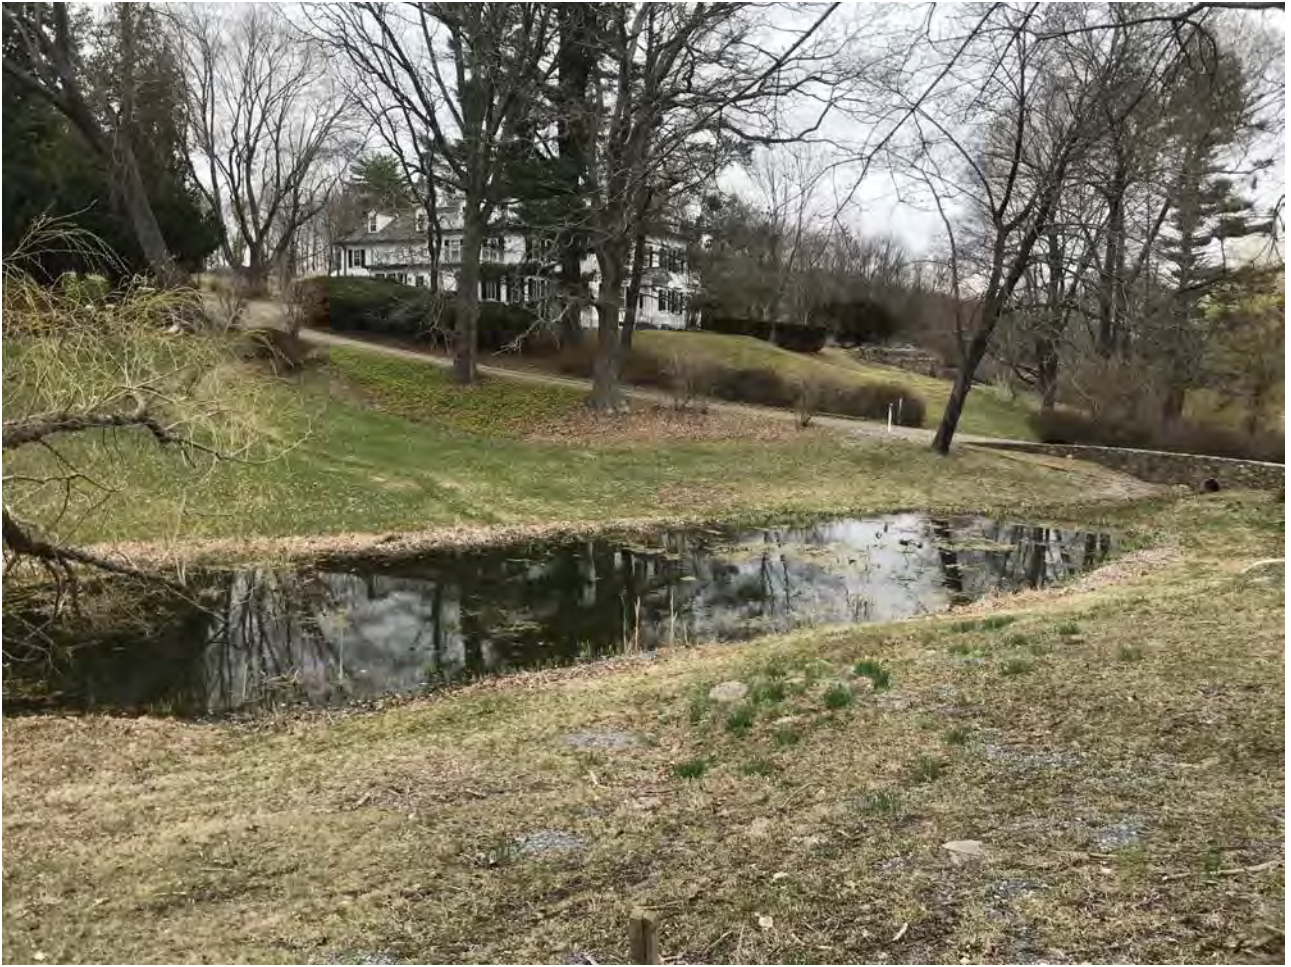
Pond 2 is assumed to be Corps jurisdictional due to observed surface water connections to other resources (Wetland F).

9. Pond 2 viewed northwest

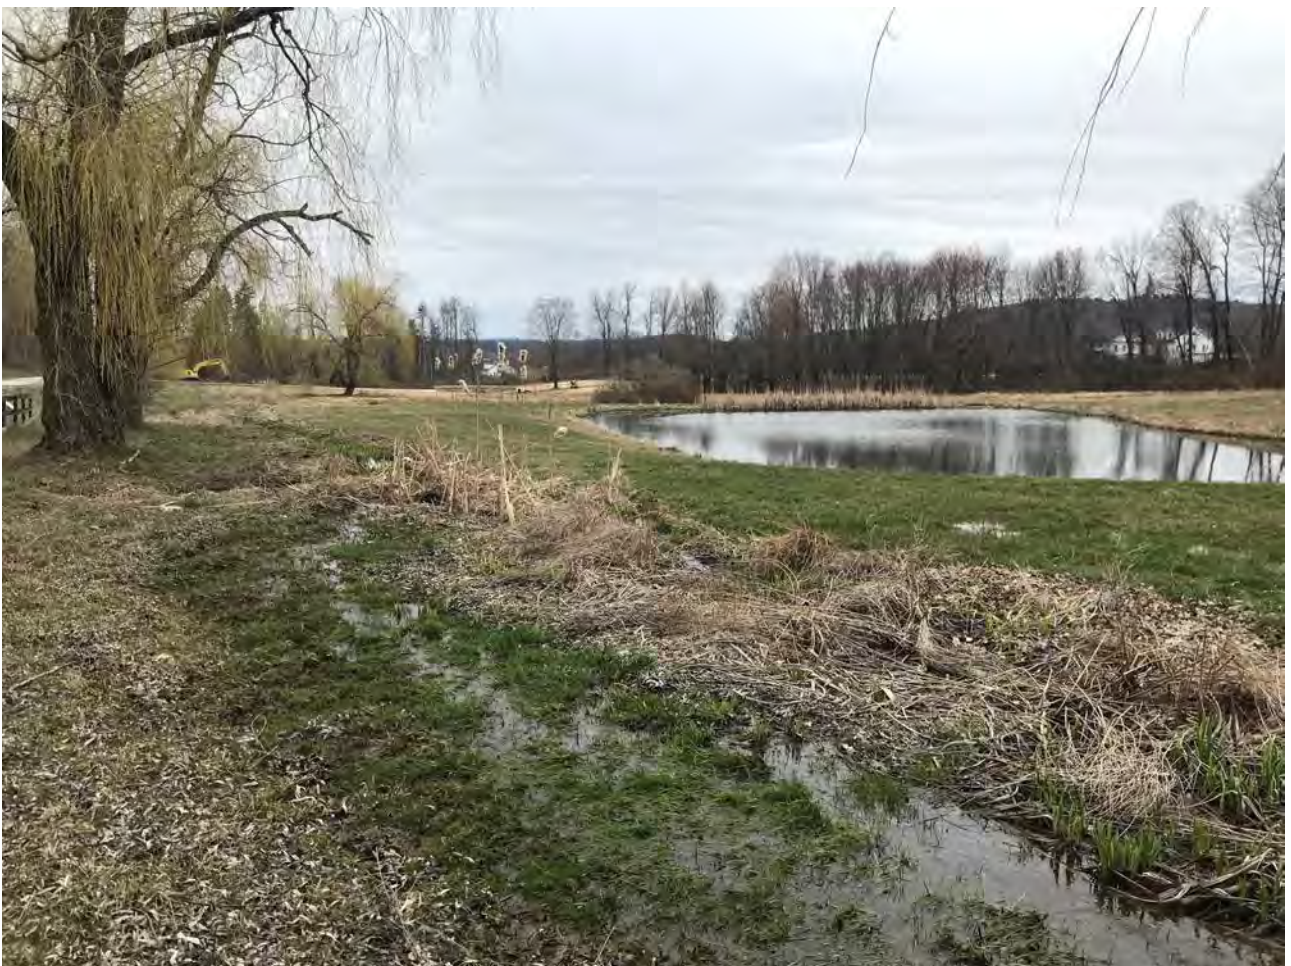
**Wetland F** is a PEM wetland covering approximately 0.23 acres in the northern portion of the site on the east side of Killearn Road. Several indicators of wetland hydrology were observed including saturation, geomorphic position, and FAC-neutral test. Wetland F is dominated by several species of hydrophytic vegetation including narrow-leaf cattail and sensitive fern (*Onoclea sensibilis*). Hydric silt loam soils were also observed.

10. Wetland F viewed north

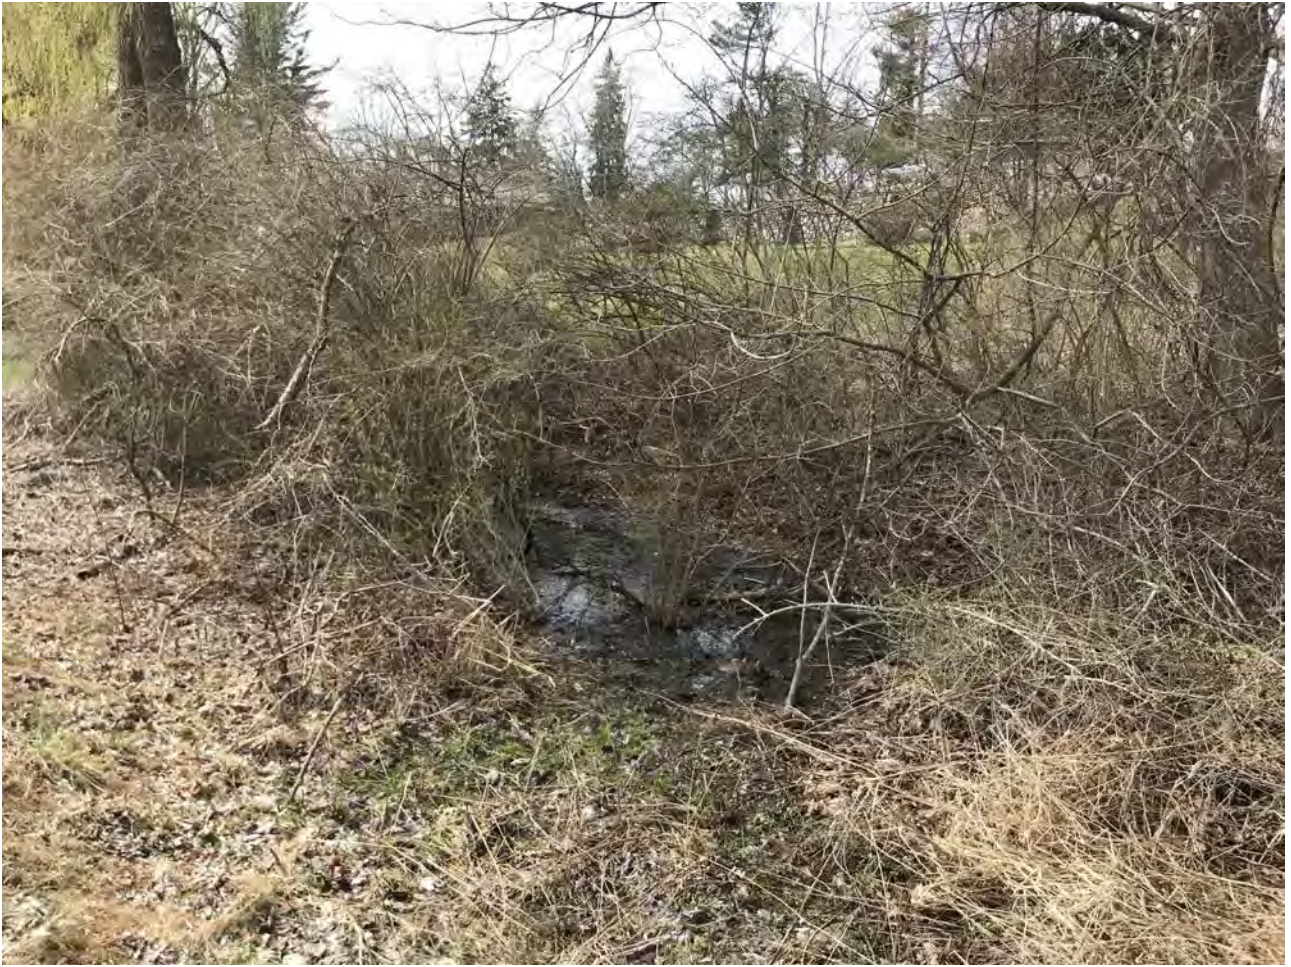
**Wetland G** is a PSS wetland covering approximately 0.02 acres in the northern portion of the site on the west side of Killearn Road and appears to be hydrologically isolated with no surface water connections to other resources. Several indicators of wetland hydrology were observed including surface water, saturation, geomorphic position, and FAC-

neutral test. Wetland G is dominated by several species of hydrophytic vegetation including grey dogwood (*Cornus racemosa*). Hydric silt loam soils were also observed.

11. Wetland G viewed southwest
