Re: *Wetland Delineation*  
*Killearn Road*  
*Town of Washington, Dutchess County, New York*  
*C.T. Male Project No. 23.3211*

Wetland Delineation

Killearn Road

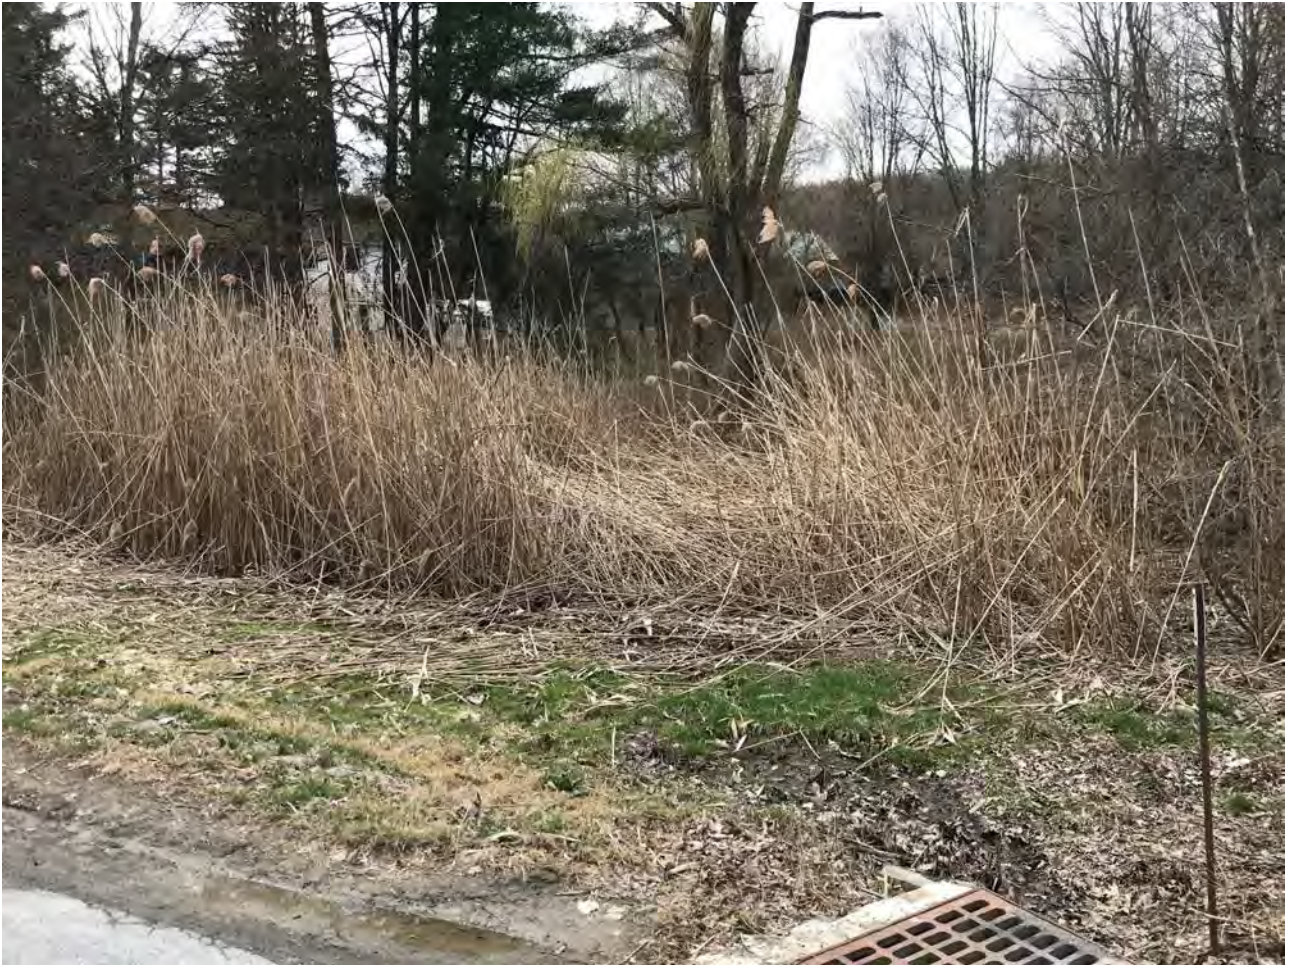
**Wetland H** is a PEM wetland covering approximately 0.16 acres on the west side of Killearn Road. Several indicators of wetland hydrology were observed including saturation, geomorphic position, and FAC-neutral test. Wetland H is dominated by several species of hydrophytic vegetation including common reed (*Phragmites australis*) and purple loosestrife (*Lythrum salicaria*). Hydric silt-loam soils were also observed.

13. Wetland H viewed southwest

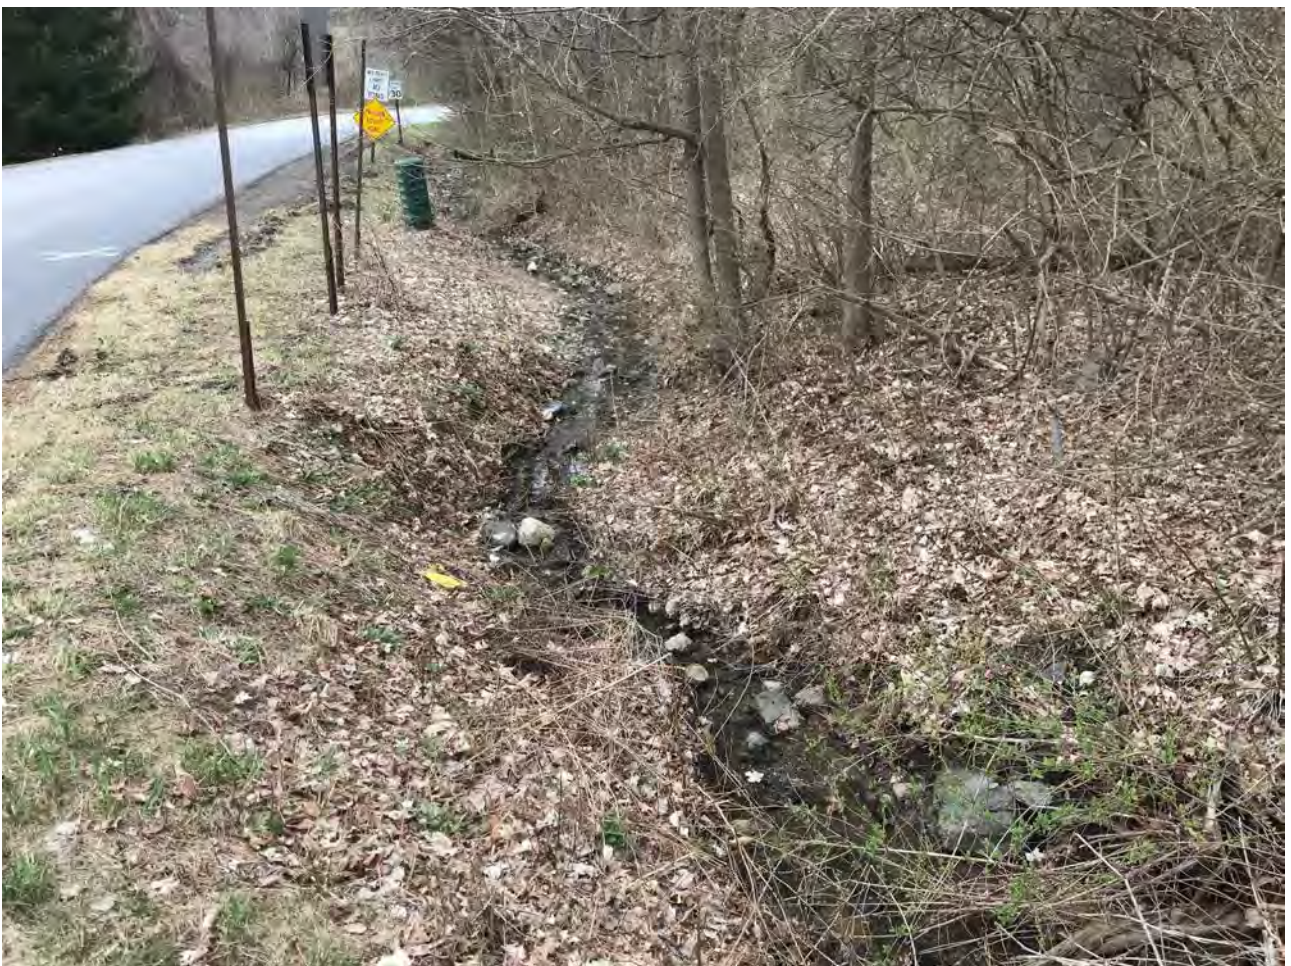
14. Drainage ditch viewed southeast
